**WASTE DISCHARGE REQUIREMENTS
PROGRESS REPORT
Q2 2015**

**Defense Fuel Support Point Norwalk
15306 Norwalk Boulevard
Norwalk, California 90650**

GeoTracker Global ID# SLT43185183
(Order No. 90-148; File No. 90-60-145; Monitoring and
Reporting Program CI-10118)
04-NDLA-007

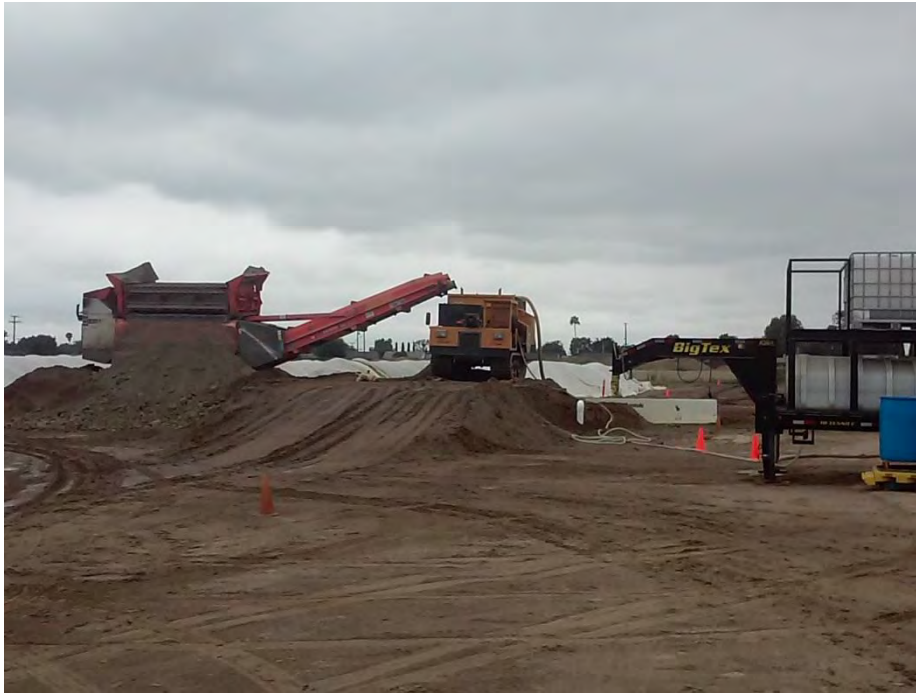
Photo 1: F4 Soil Treatment Equipment (left) and Nutrient/Microbes Trailer (right).

Contaminated soil is treated by processing through an Earth Cleaning Machine provided by F4 Remediation, Inc. As soil is fed into the machine, a mixture of non-toxic surfactant and non-pathogenic microbes is mixed throughout the soil, and the soil is then discharged for placement into piles within the treatment cells, as shown in the attached photos. Soil moisture is monitored in several ways, including monthly sampling and laboratory testing, tensiometer probe testing, and infrared imaging. Additional water and nutrients did not need to be added to the soil piles during the treatment period.

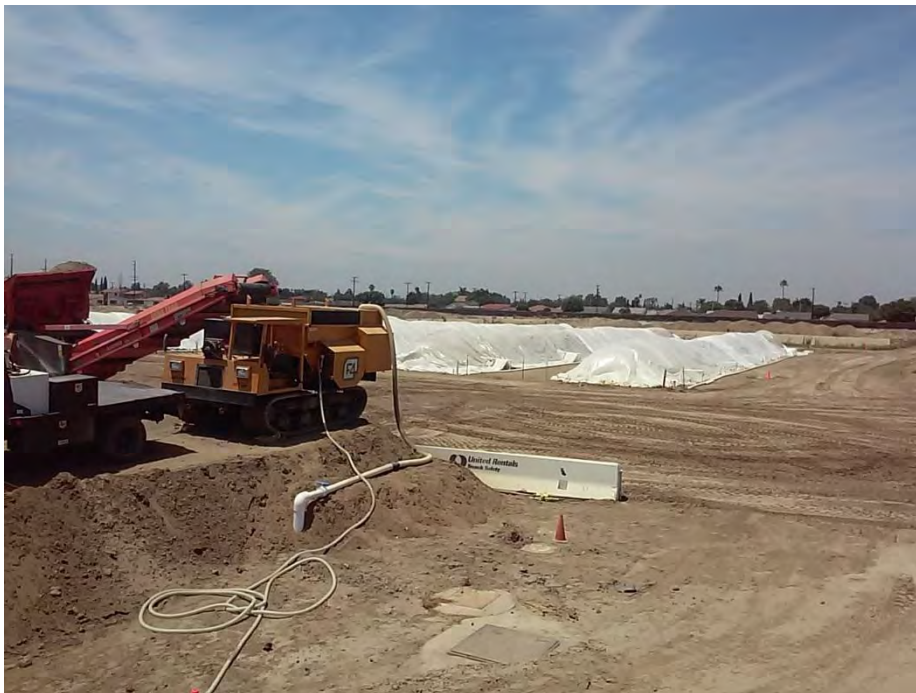
Photo 2: F4 Nutrient and Microbe mixing machine.

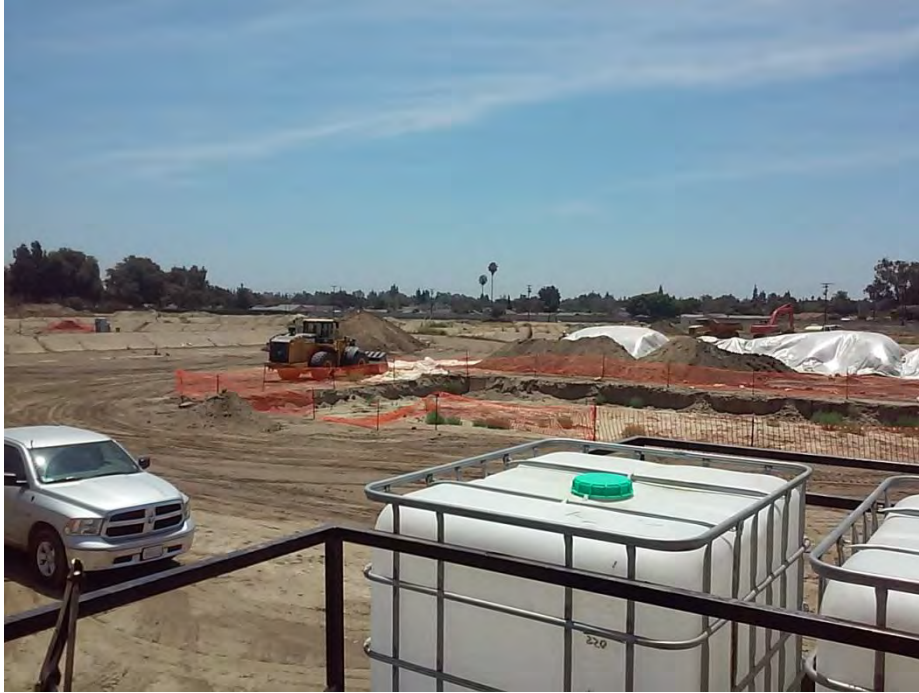
Photo 3: Treatment Soil Pile construction –
View from F4 nutrient tank platform.

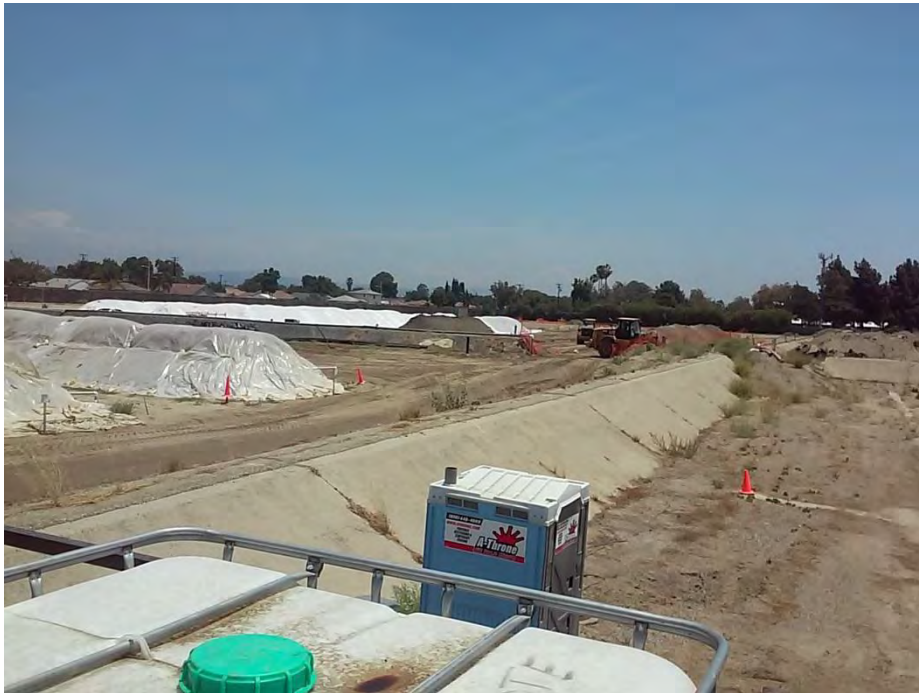
Photo 4: Soil Treatment Piles.

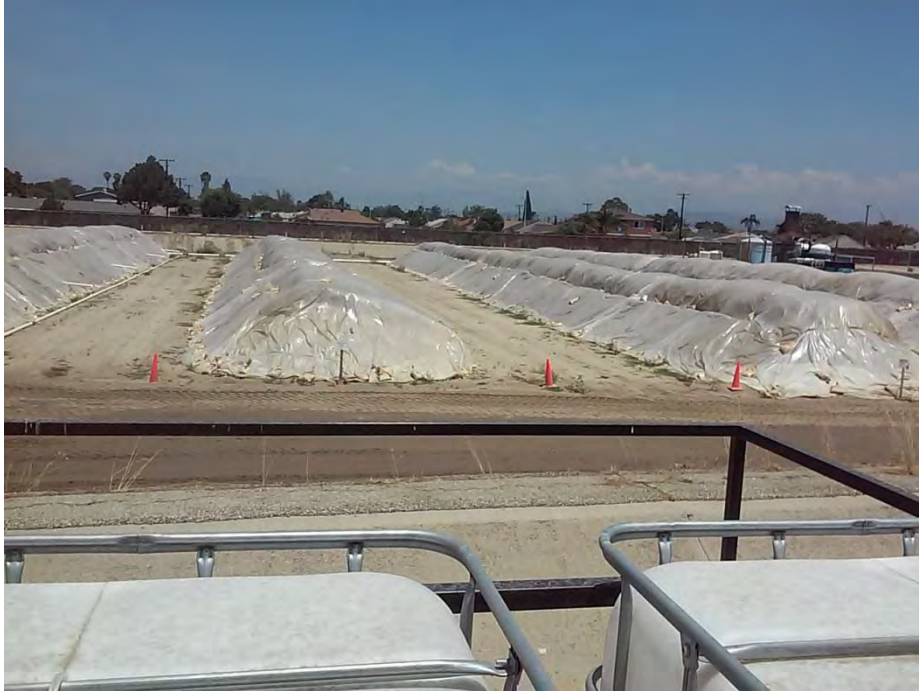
Photo 5: Soil Treatment Piles.

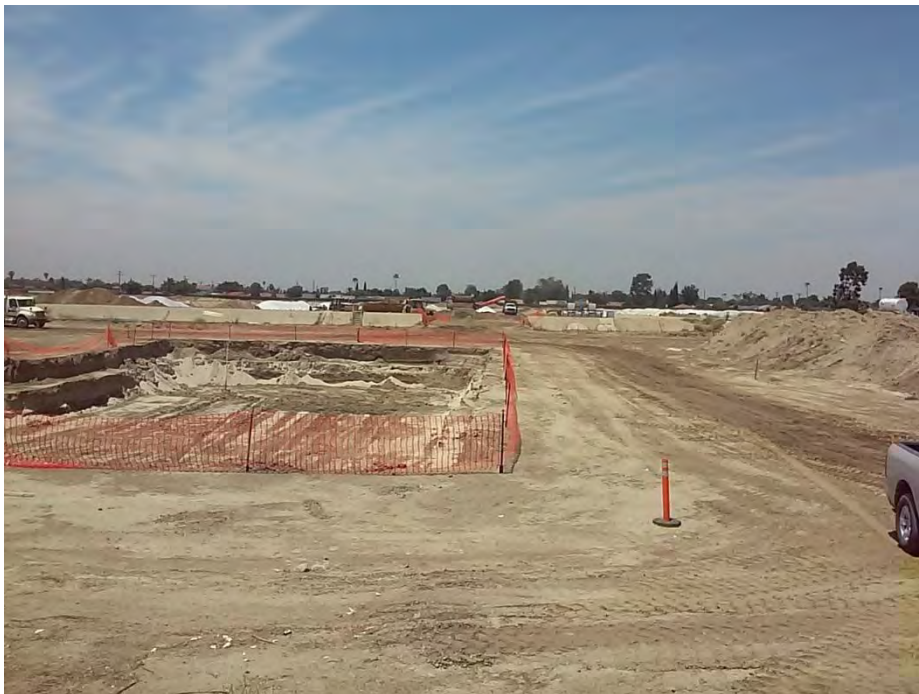
Photo 6: Example photo of Excavation (Excavation #2).

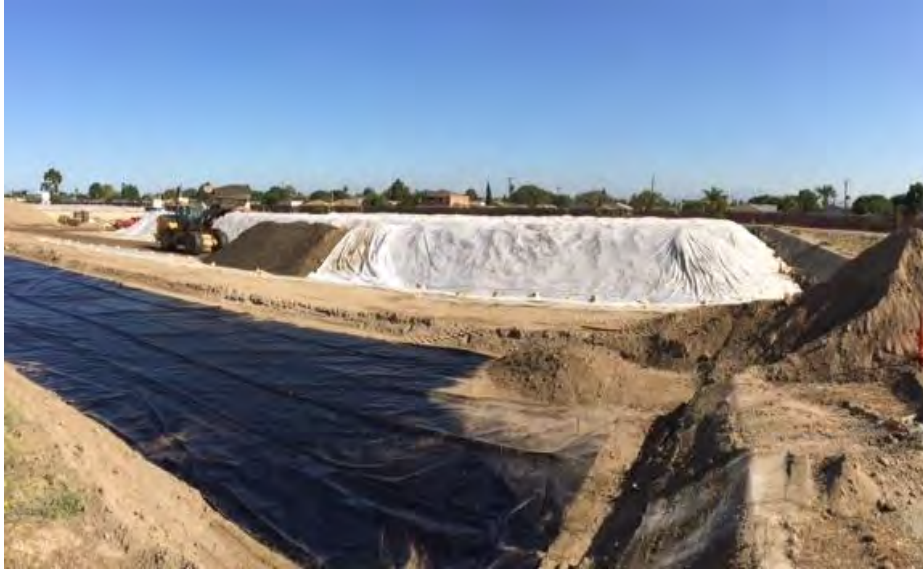
Photo 7: Liner emplacement under treatment stockpile.

To further protect the soil beneath the treatment piles, 30mm high density polyethylene (HDPE) liners were placed six inches below the ground surface beneath the treatment piles.
