SOIL REMEDIATION PHASES 2 AND 3 COMPLETION REPORT

Defense Fuel Support Point Norwalk 15306 Norwalk Boulevard Norwalk, CA 90650

04-NDLA-007

October 16, 2015

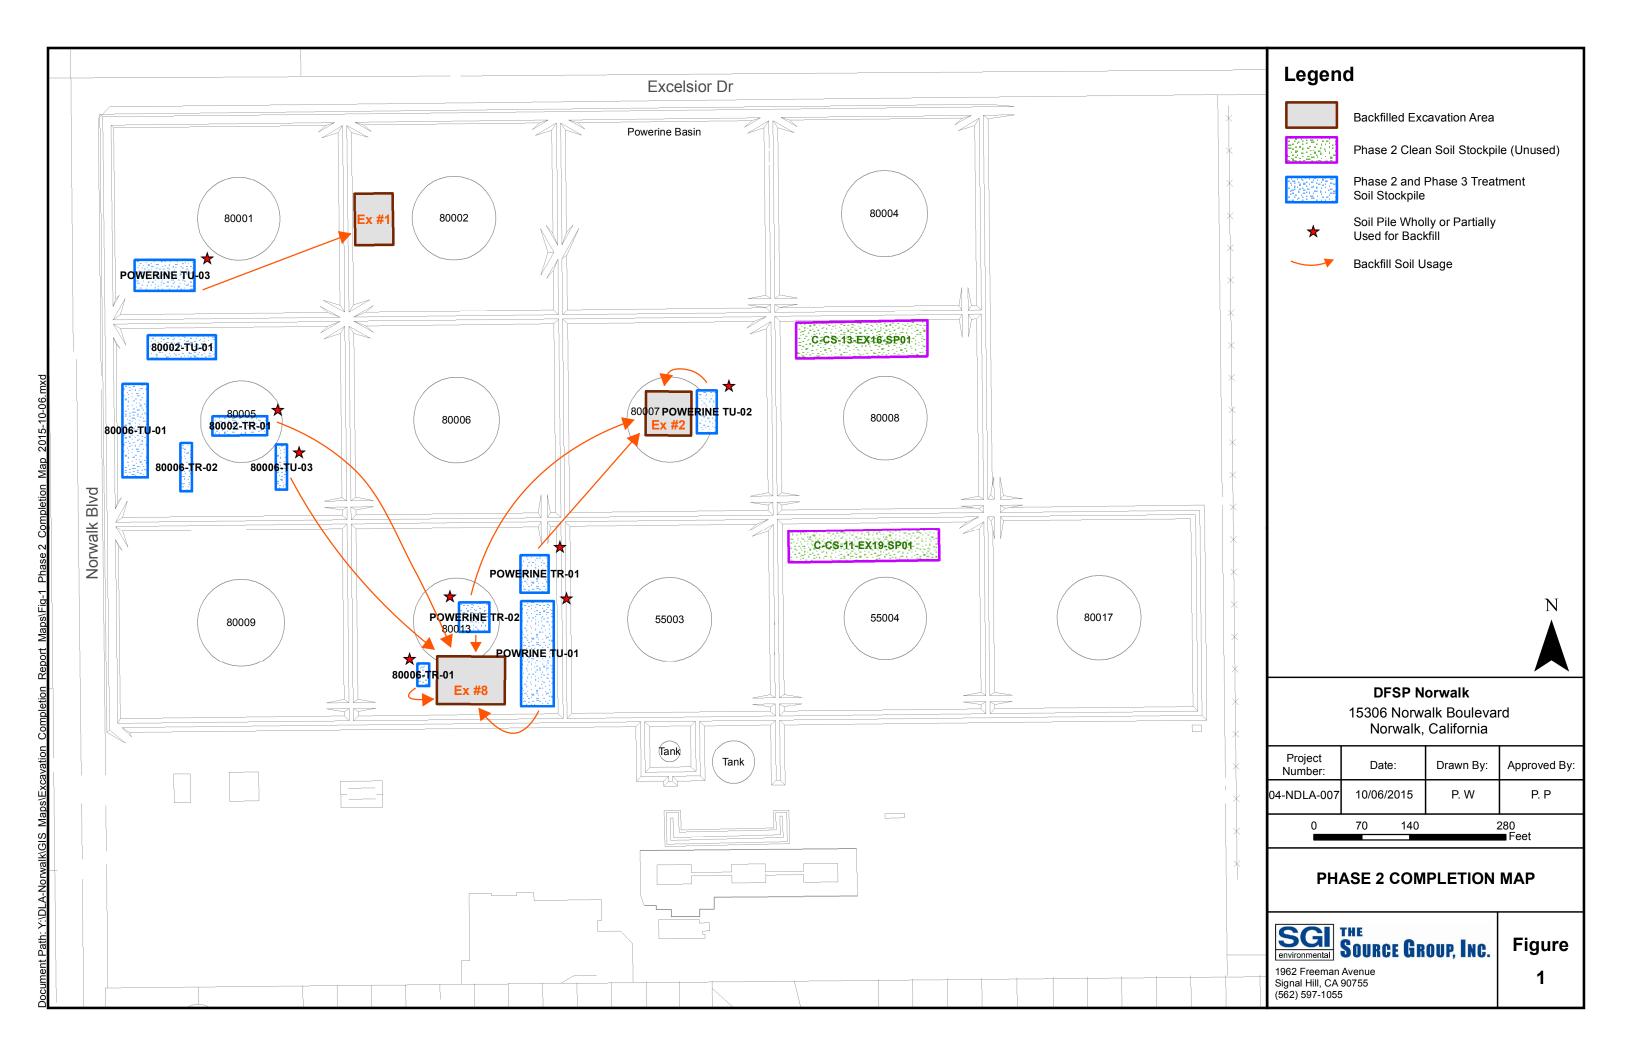
Figure 1 Phases 2 and 3 Completion Site Map

Figure 1 presents a site map with the locations of Excavations #1, #2, and #8; Phase 2 clean soil stockpiles CS-11 and CS-13; Phase 2 treated soil stockpiles Powerine-A through D; and Phase 3 treated soil stockpiles 80002-A through 80002-E and 80006-A through 80006-E.

Figure 1 illustrates the soil handling during backfilling of three excavations and Appendix A includes photo documentation of the backfilling. Table 2 presents a summary of excavations at the site.

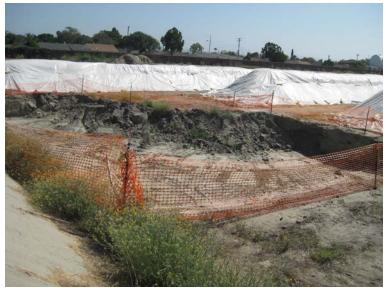
Photo 1: Excavation #1 prior to backfilling. View to the northeast.

Excavation #1 was backfilled on September 28, 2015. Backfilling included addition of potable water to ensure compaction and the placement of soil in approximate one-foot thick lifts. Third party oversight of all compaction activities and the performance of confirmation testing to ensure a minimum of 90% of Standard Proctor were provided by Albus-Keefe & Associates of Anaheim, CA. The southern end of Excavation #1 was only partially backfilled to allow usage of that lower elevation area for temporary storm water collection. Soil used for backfilling consisted of treated soil from Powerine Basin treated soil piles.

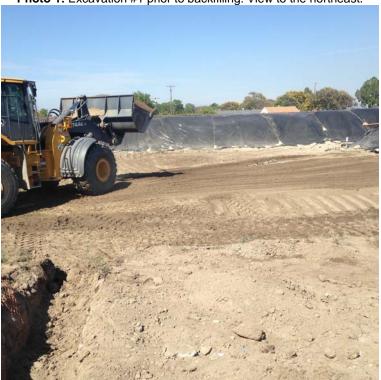
Photo 2: Excavation #1 during backfilling. View to the north.

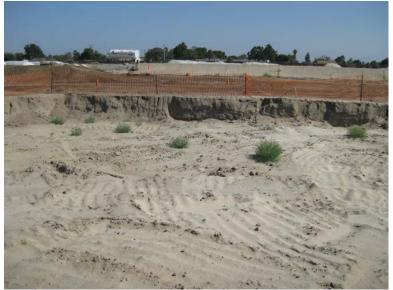
Photo 3: Excavation #2 prior to backfilling. View to the northwest.

Excavation #2 was backfilled on September 9, 2015. Backfilling included addition of potable water to ensure compaction and the placement of soil in approximate one-foot thick lifts. Third party oversight of all compaction activities and the performance of confirmation testing to ensure a minimum of 90% of Standard Proctor were provided by Albus-Keefe & Associates. Soil used for backfilling consisted of treated soil from Powerine Basin treatment soil piles.

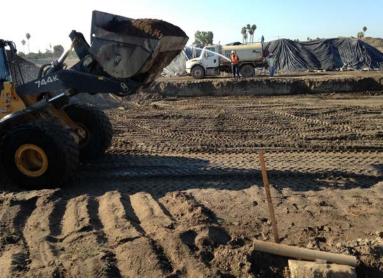
Photo 4: Excavation #2 during backfilling. View to the south.

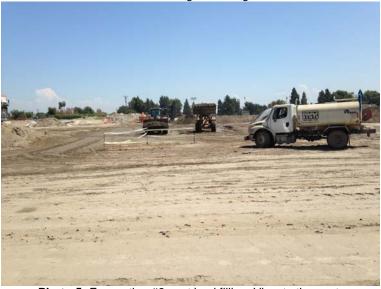
Photo 5: Excavation #2 post backfilling. View to the east.

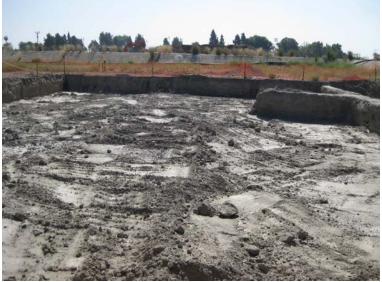
Photo 6: Excavation #8 prior to backfilling. View to the east.

Excavation #8 was backfilled on September 24, 2015. Backfilling included addition of potable water to ensure compaction and the placement of soil in approximate one-foot thick lifts. Third party oversight of all compaction activities and the performance of confirmation testing to ensure a minimum of 90% of Standard Proctor were provided by Albus-Keefe & Associates. Soil used for backfilling consisted of treated soil from Powerine Basin treatment soil piles. In addition, as illustrated on Figure 1, backfilling of Excavation #8 also required soil reuse from treated soil approved as part of Phase 3.

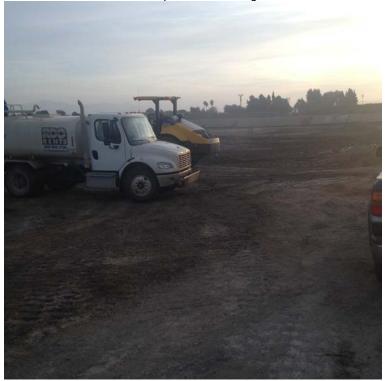
Photo 7: Excavation #8 during backfilling. View to the east.
