# *Norwalk Tank Farm Update*

*Defense Energy Support Center-  
Americas West  
Norwalk Tank Farm  
Restoration Advisory Board*

*April 22, 2004*

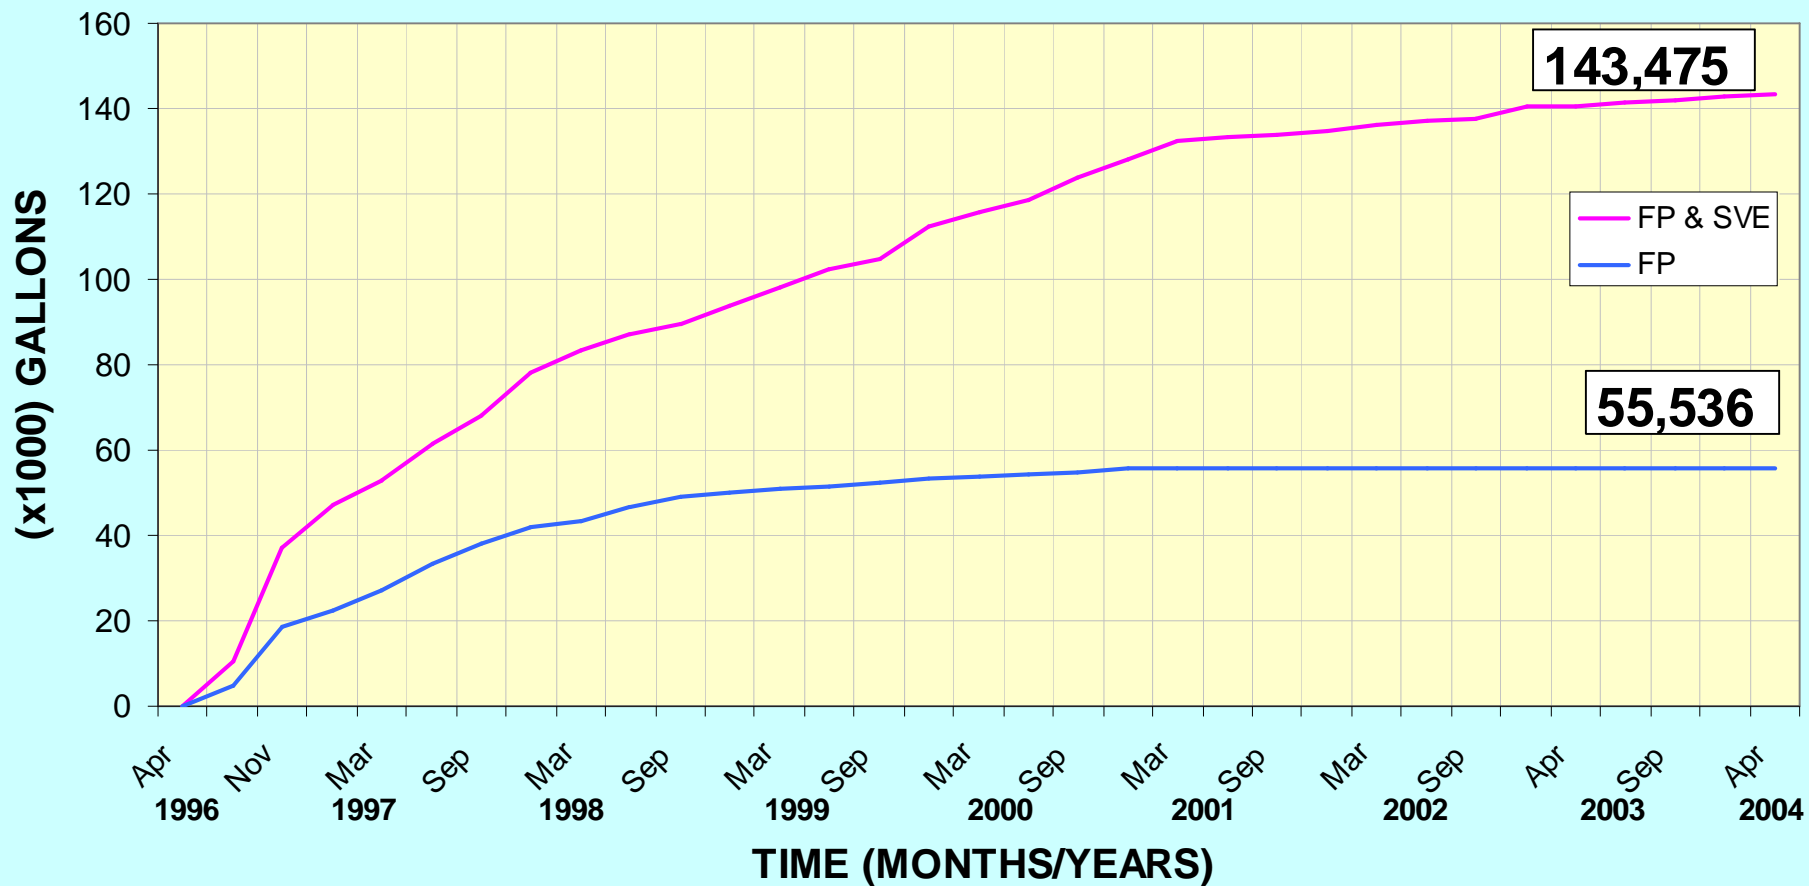
## HYDROCARBONS & FREE PRODUCT-CENTRAL PLUME

- System Performance since April 1996
  - Total Hydrocarbons Mass Removed:  
261,367 gallons
    - Approx. 143,475 gallons recycled and destroyed
      - 55,536 gallons of free product recovered
      - 86,542 gallons of volatile hydrocarbons recovered through soil vapor extraction
      - 1,397 gallons of dissolved phase hydrocarbons recovered
    - Estimated 117,892 gallons of hydrocarbons destroyed due to enhanced biodegradation
  - 42.2 M gallons of water treated

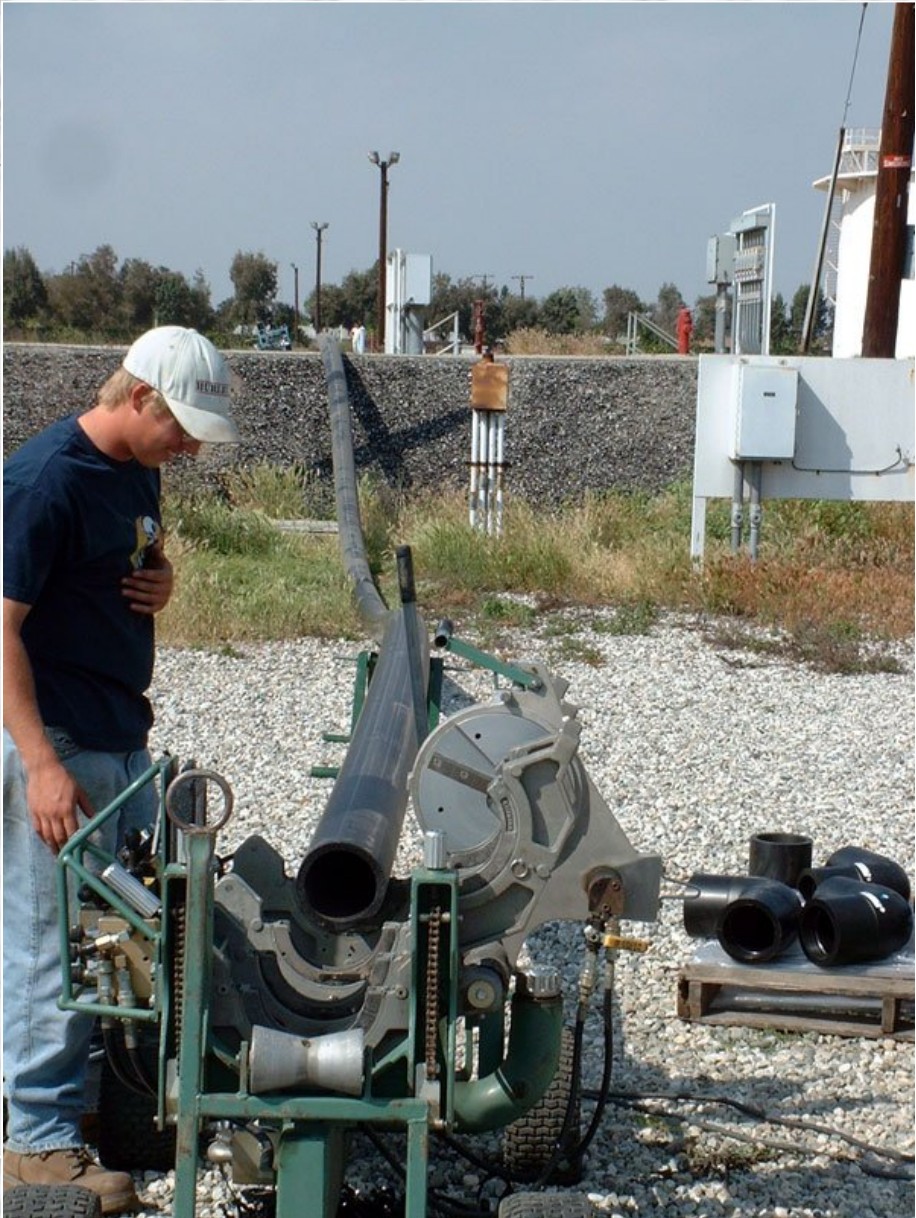
**FIGURE 1 – HDPE PIPE INSTALLATION**

- Vapor extraction system installed at former truck rack
  - 5 soil borings
  - 3 vapor monitoring points
  - 8 vapor extraction wells (incl. 2 existing)
- Connected using HDPE pipe to Central Treatment Plant
- Field measurements indicate elevated vapor concentrations--Awaiting laboratory results
- Extraction started on April 20

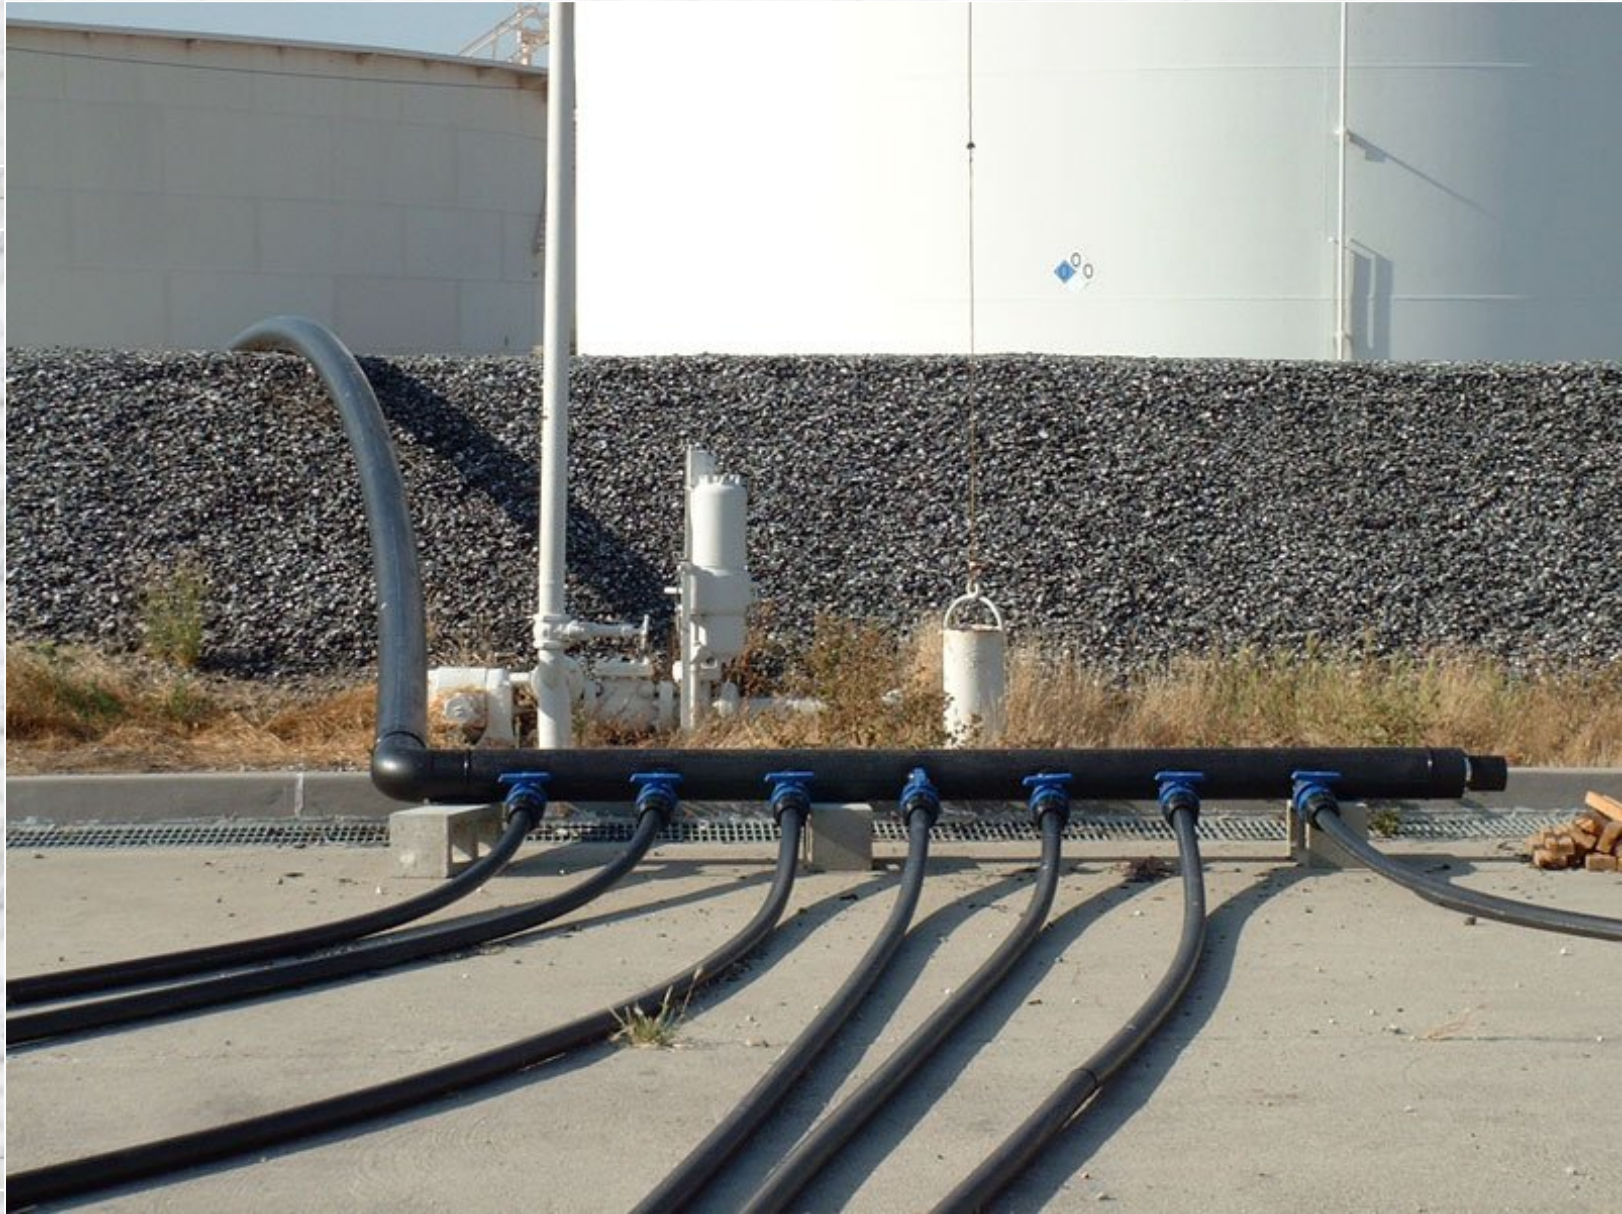
**FIGURE 2 – TRUCK FIELD STAND MANIFOLD**

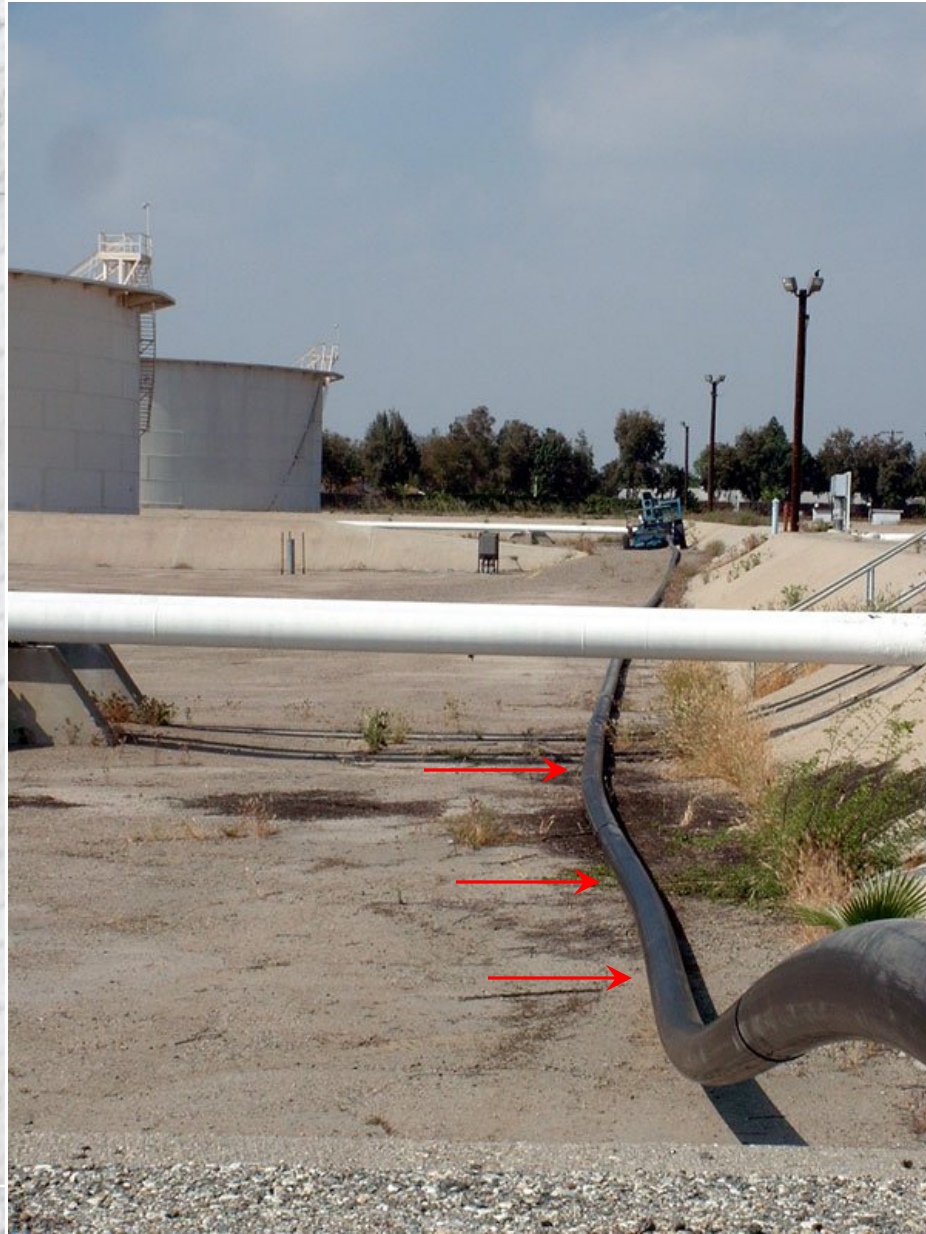
**FIGURE 3 – HDPE PIPE ROUTE**

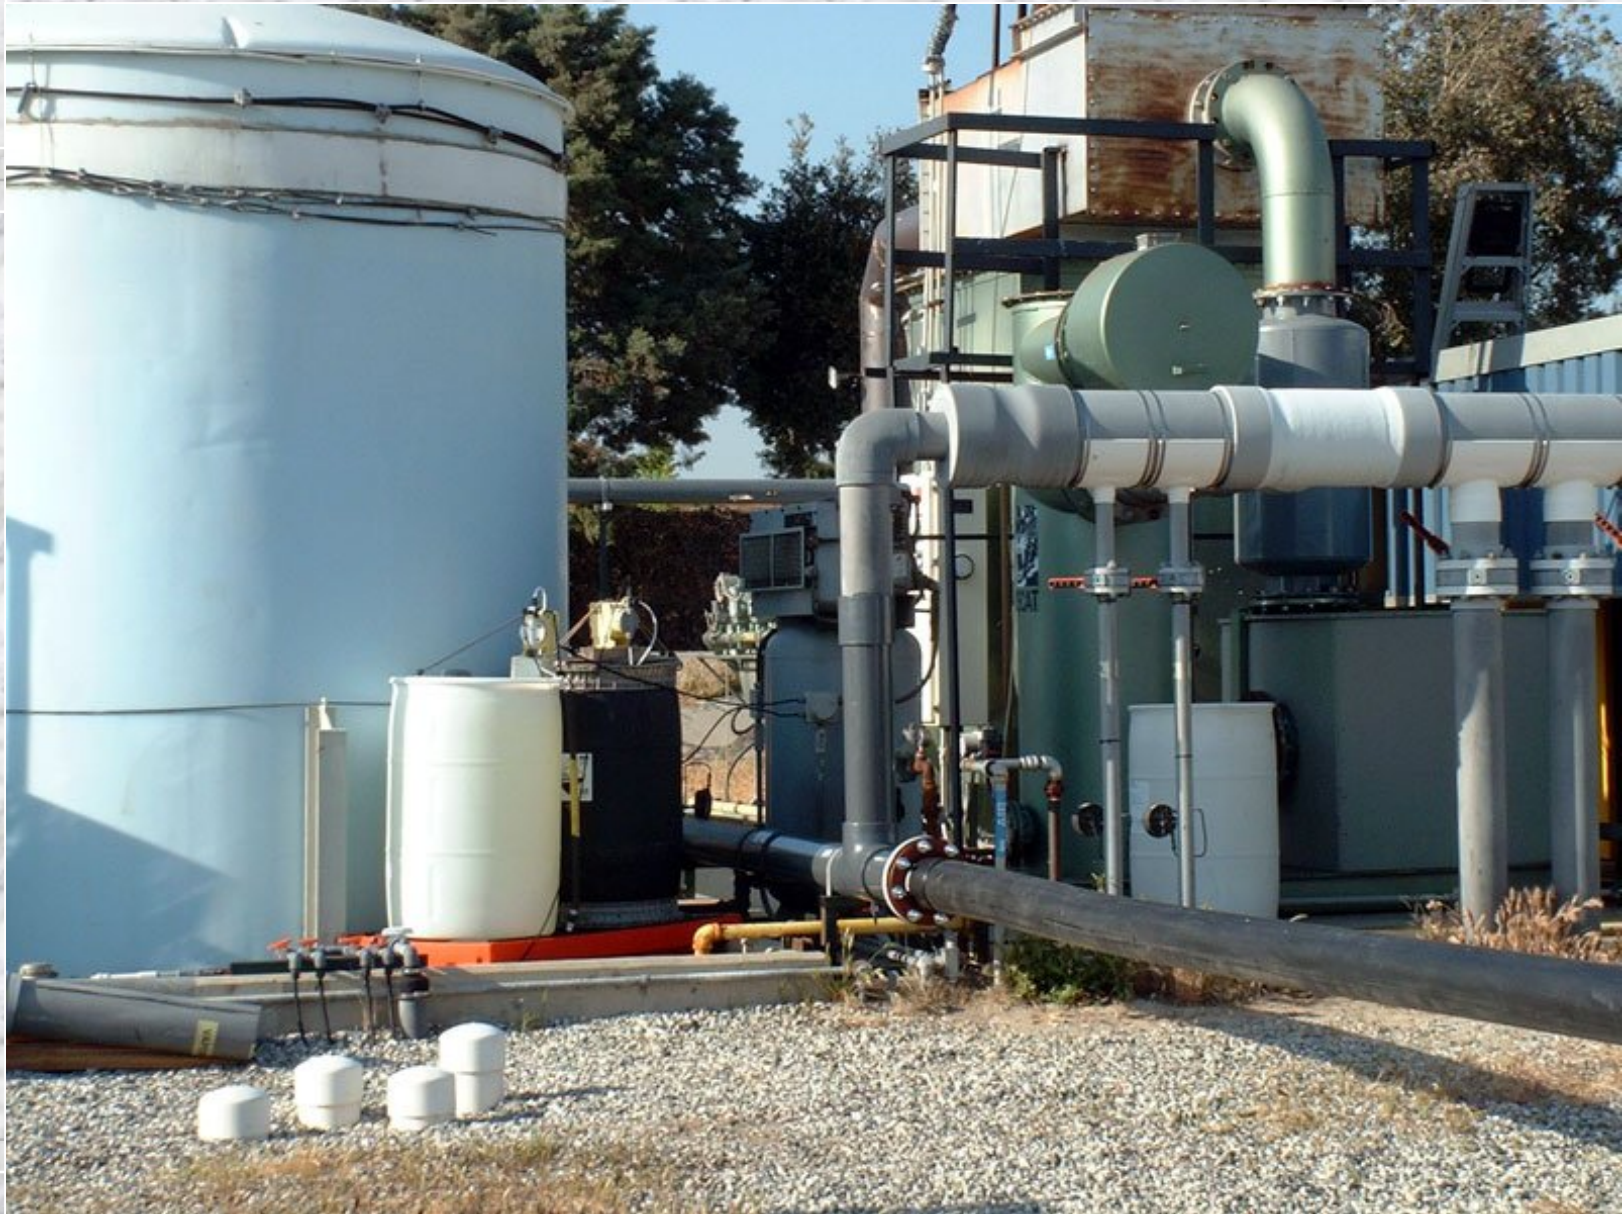
**FIGURE 4 – FINAL CONNECTION TO SVE SYSTEM**

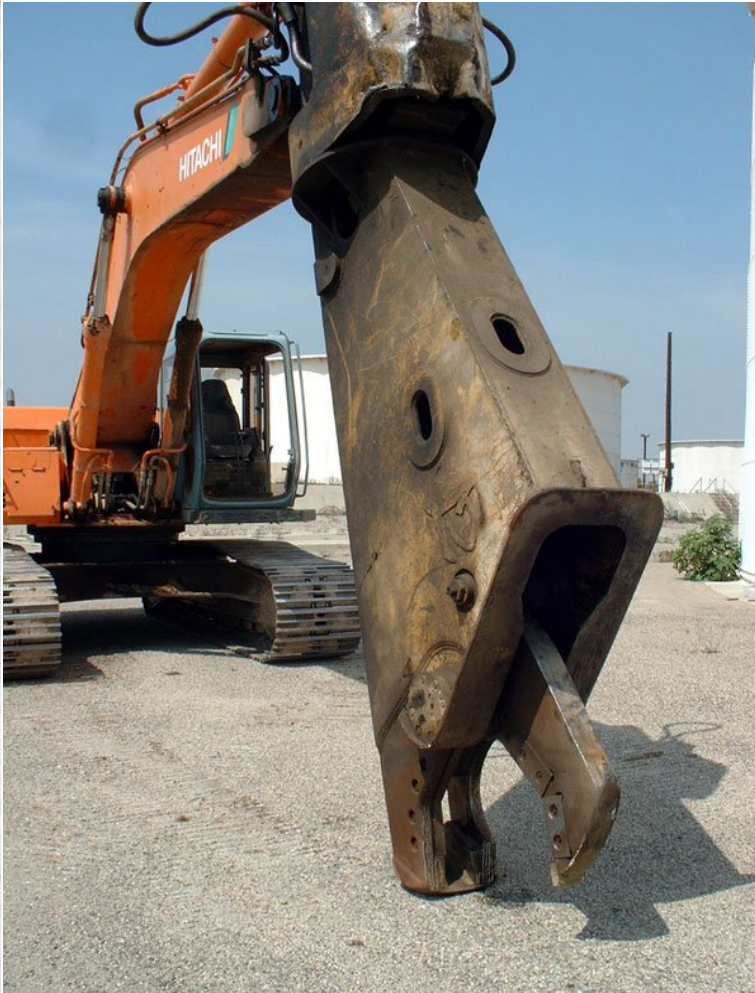
**FIGURE 1 – HYDRAULIC  
SHEAR CUT**

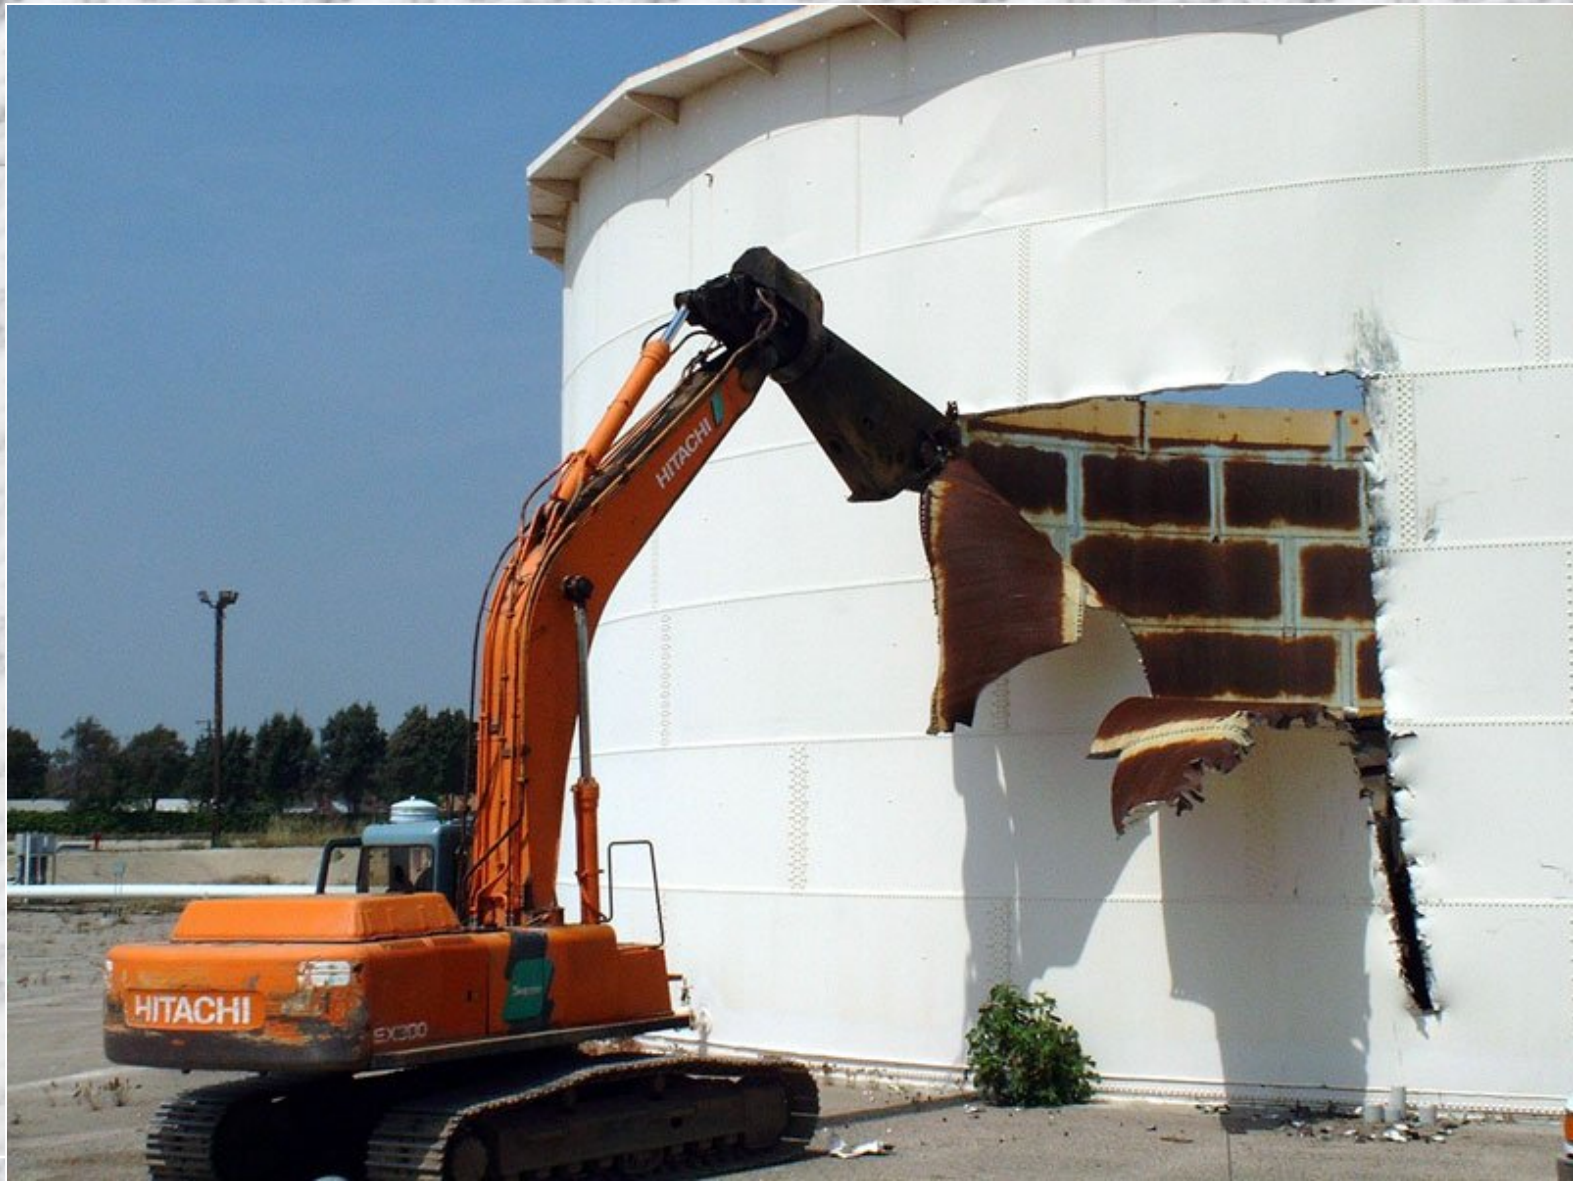
**FIGURE 2 – SHEAR CUTTING FOR ACCESS**

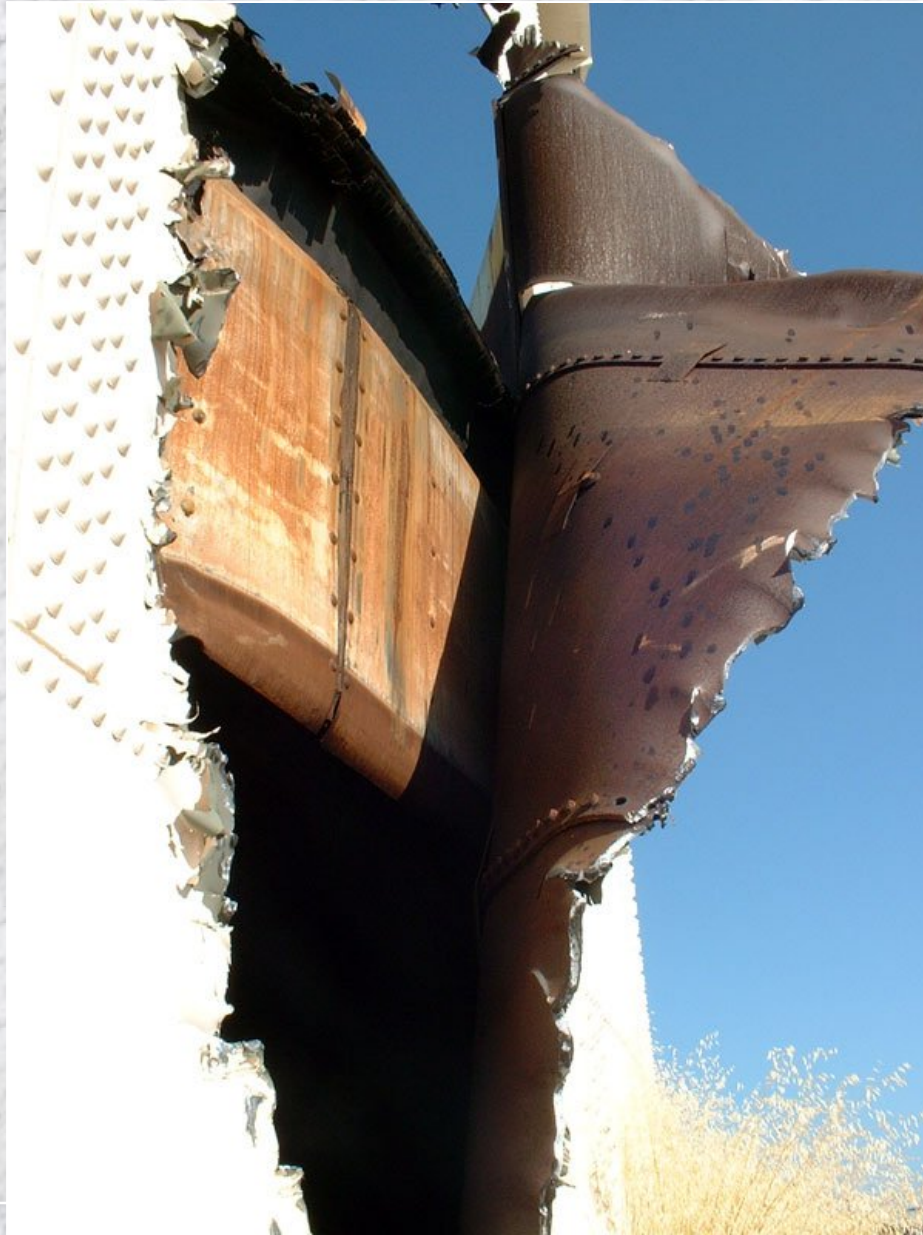
**FIGURE 3 – FLOATING ROOF INSIDE OF TANK**

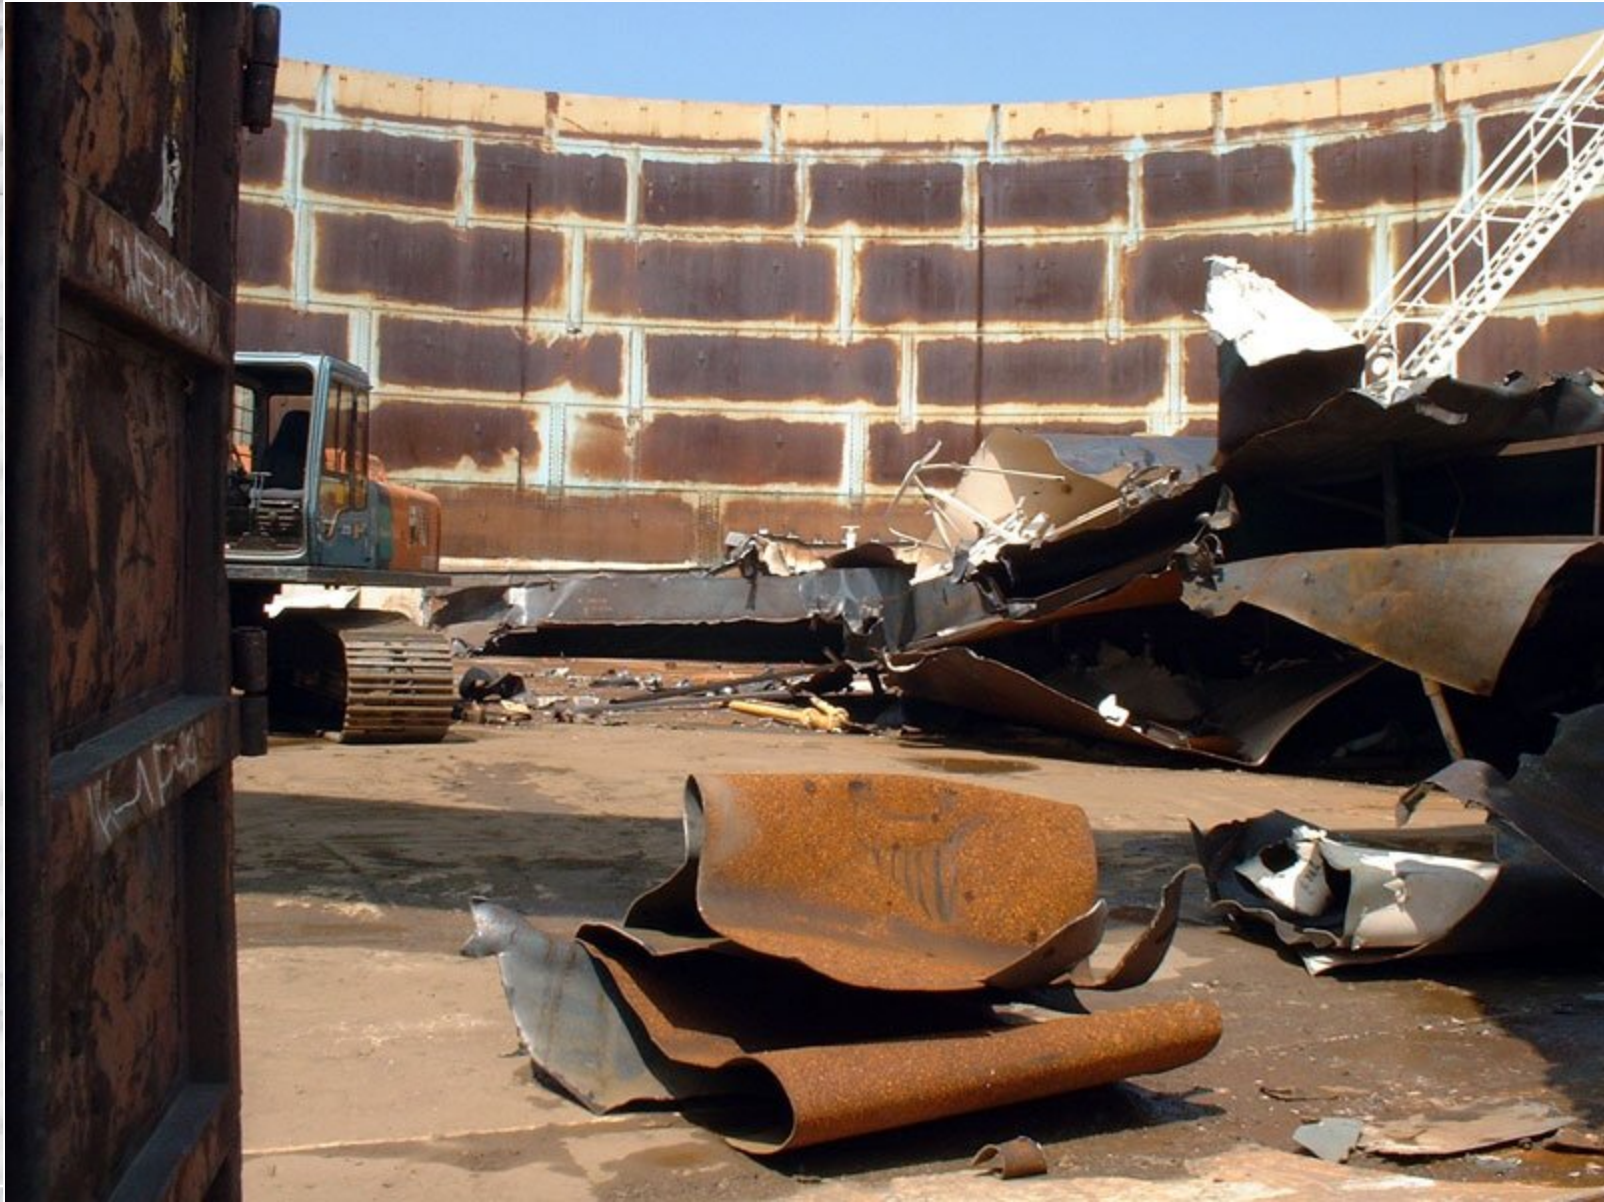
**FIGURE 4 – FLOATING ROOFTOP DEBRIS**

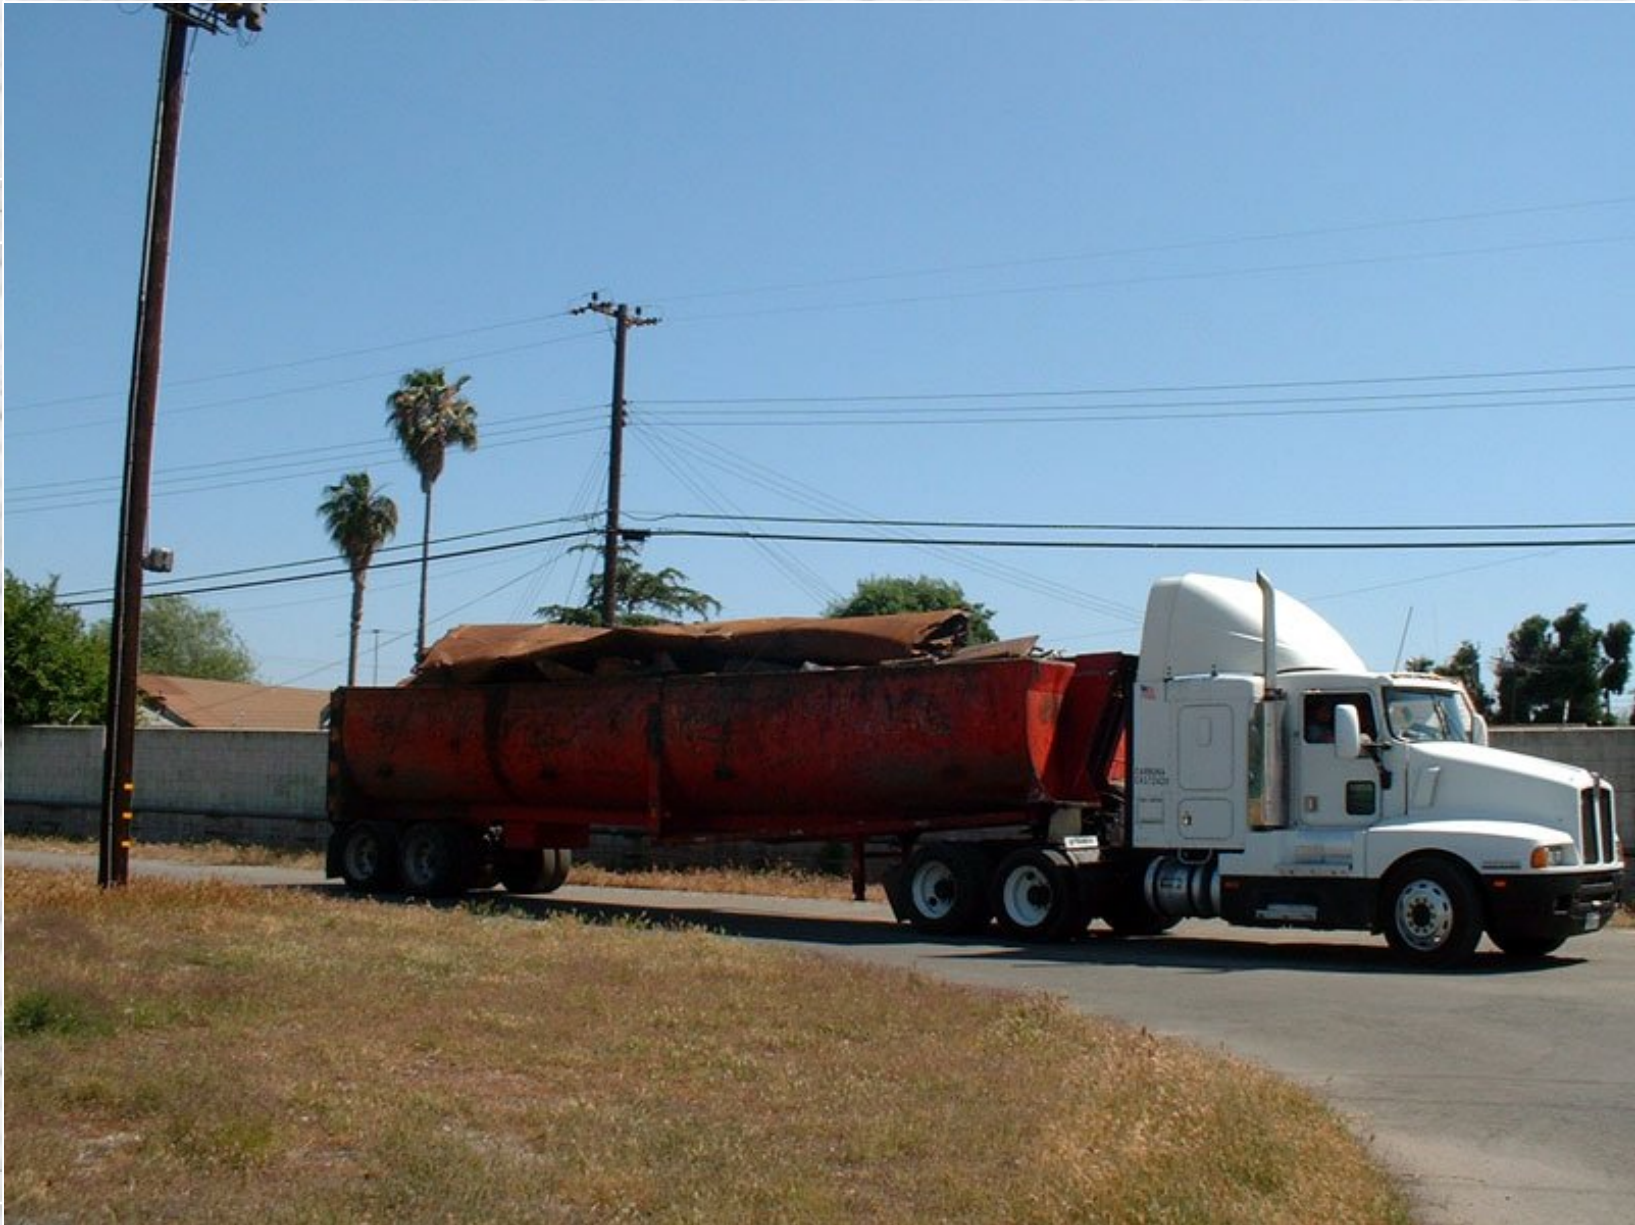
**FIGURE 5 – HAULING OF DEBRIS**
