Cardinal Yu Pin Manor

**SFPP Norwalk Tank Farm Update  
Presented to the  
Norwalk Restoration Advisory Board on  
February 28<sup>th</sup>, 2019**

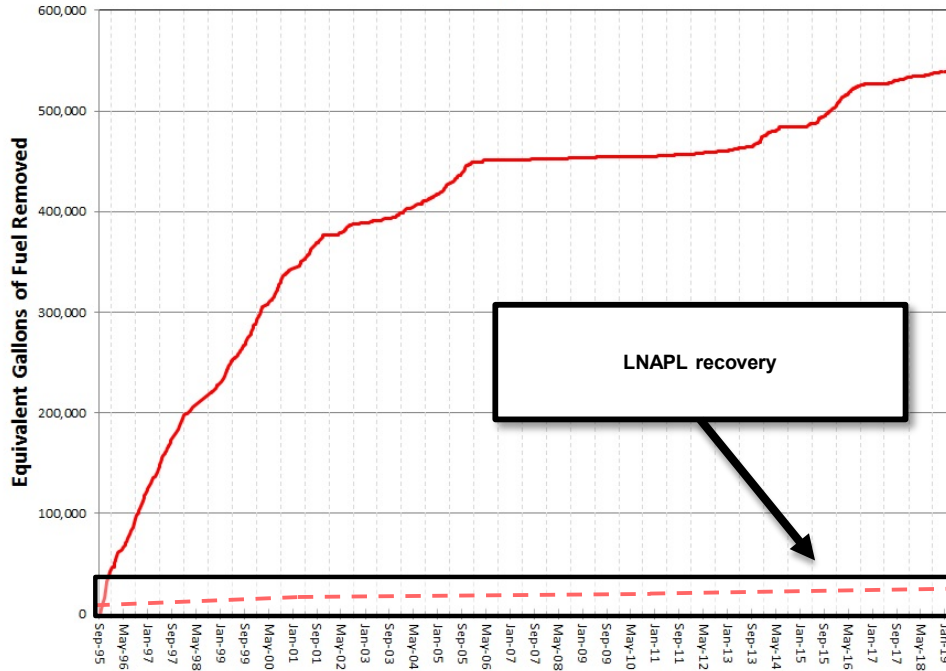
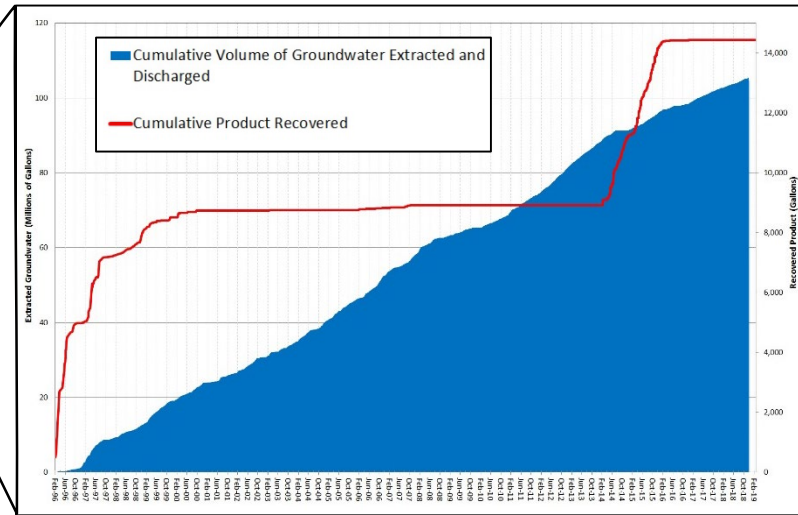
Cumulative Fuel Removed by Vapor Extraction To Date

# Site Mass Recovery Summary

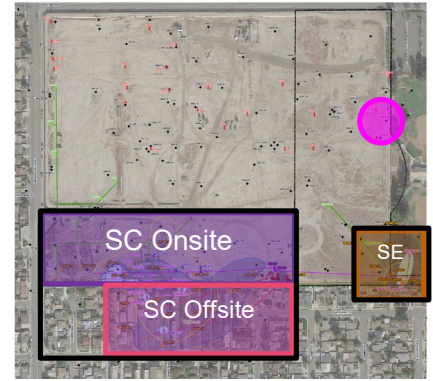
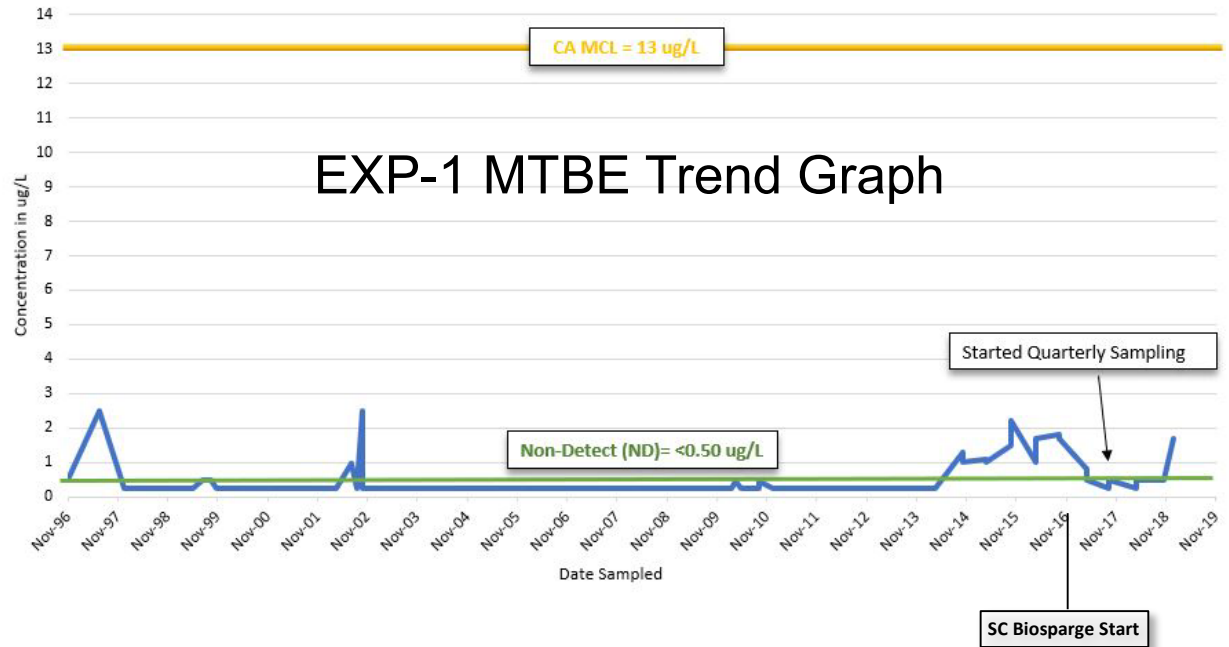
- 5 wells screened in Exposition Aquifer, only one with detections in the last 10 years
- EXP-1 below MCLs, no increasing trend
- 6 of the last 7 results were non-detect.
- Return to semi-annual sampling frequency

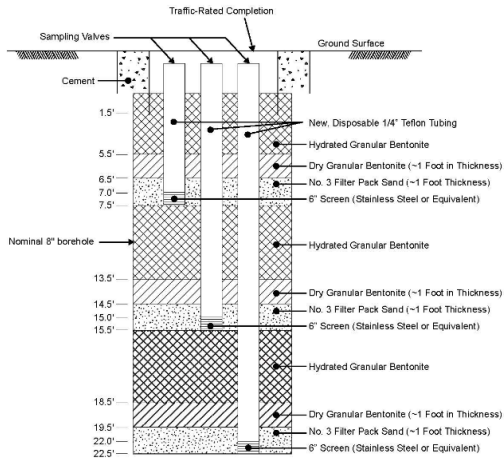
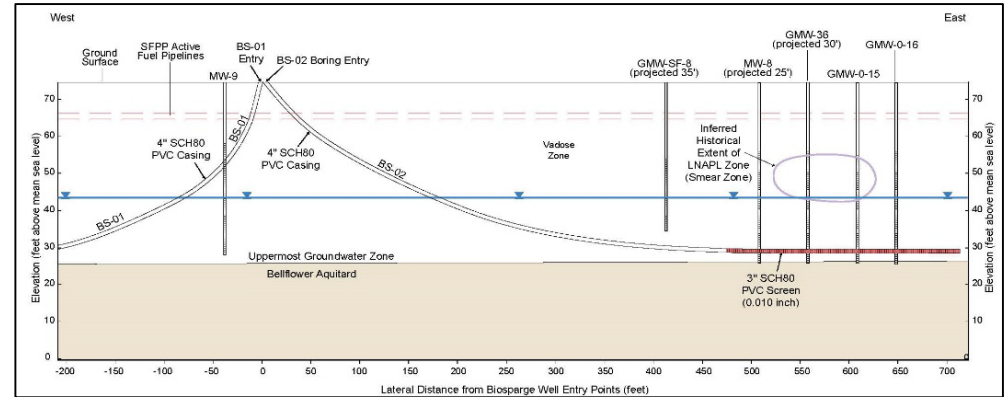
## Well Casing and Screen

- SCH 80 PVC 4-inch diameter well
- Open slot design (no sand pack required); slot width 0.012 inches
- Screen depth of 45 feet bgs
- Total length = 733 feet
- 493 feet of riser casing; 240 feet of screen

## Soil Vapor Monitoring Probe Network

- SVM-9, -17, -21, -22, -23, etc.
- Double or Triple Nested (7, 15, 22 feet bgs)

# Southeastern Biosparge Well

- 733 feet long with 240 feet of screen
- Screen is located within the approximate extent of the dissolved phase in the southeast area and below the LNAPL smear zone (approximately 45-feet bgs)
- Air flow into BS-02 will be limited to 192 SCFM (0.8 SCFM/ft of screen)
- Will install 3 additional SVE wells and 2 SVP
- Expect to initiate biosparging in Q2 2019

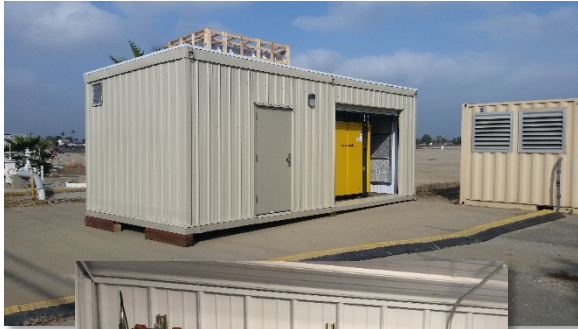
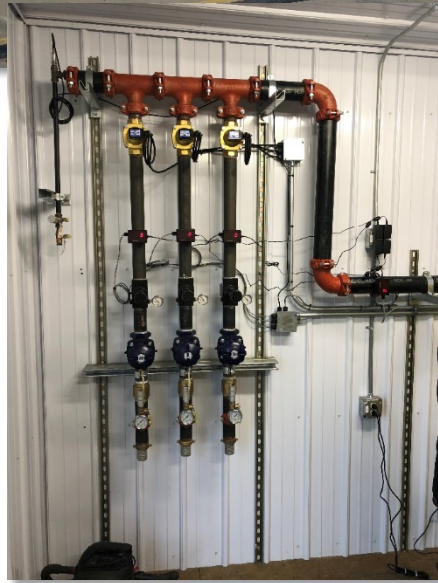
# New Biosparge Compressor (175HP)

- Compressor upgraded to operate both the onsite south-central and southeastern biosparge well.
- Installation was completed in 4Q 2018
- Testing in Q1 2019
- Compressor will be activated in Q2 2019

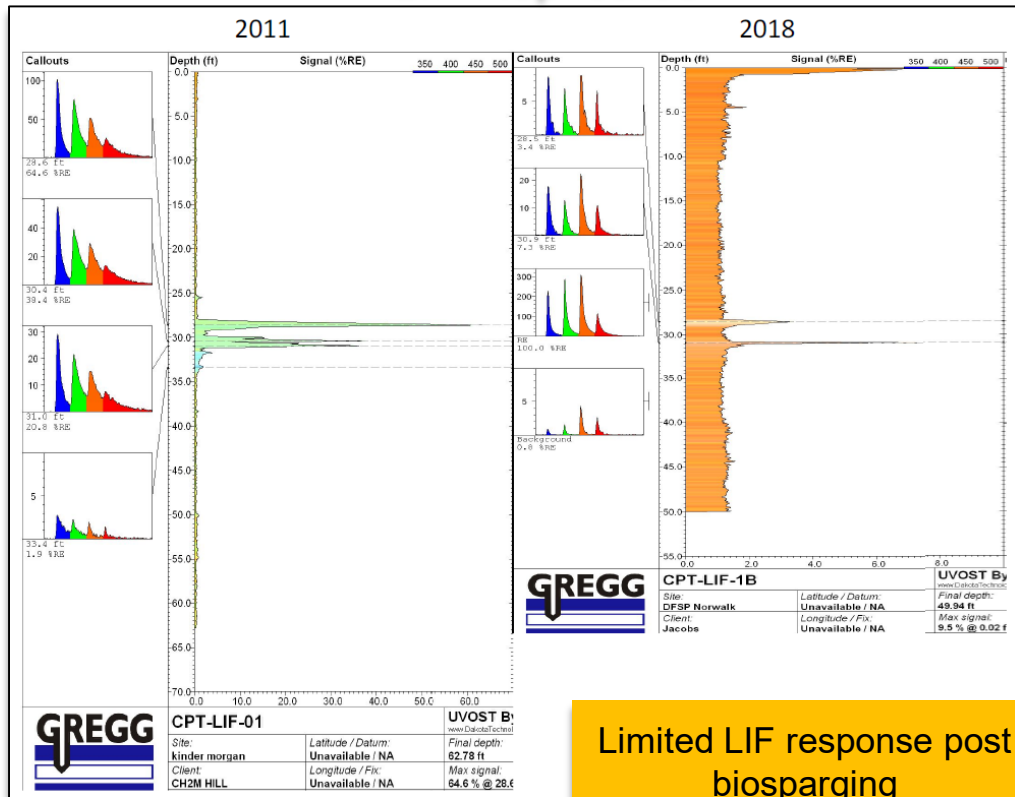
## LIF Replicates

Limited LIF response post biosparging

- LIF decreased to near non-detectable response at comparable locations and depths from 2011 to 2018.
- Photographs of soil cores also do not show petroleum hydrocarbons.
- TPH soil concentrations have decreased at almost all sample locations by at least 95%.
- There was an absence of measurable LNAPL in monitoring wells (within the treatment area) during second quarter 2018 groundwater monitoring compared to the 2011 investigation when measurable product was detected.

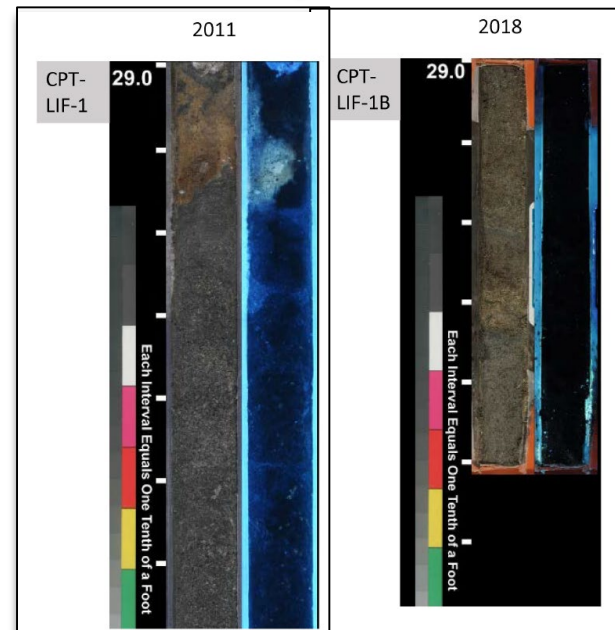
## Soil Core Photograph Replicates

No visual fluorescence post biosparging
