**SFPP Norwalk Tank Farm Update
Presented to the
Norwalk Restoration Advisory Board on
February 27th, 2020**

1. Site Overview
2. Remediation Systems Operations Update
 - SVE and Biosparge Systems
 - Groundwater and Total Fluids Extraction Systems
 - Mass Recovery Summary
3. Remediation System Expansion
 - Success with South-central Area Biosparge Well
 - Installation of Southeastern Biosparge Well
 - Expanded SVE System in Southeastern Area
 - South-central/Offsite “Stacked” Biosparging & SVE Well System
4. Path Forward
 - Road Map
 - Natural Source Zone Depletion (NSZD) Rate Evaluation

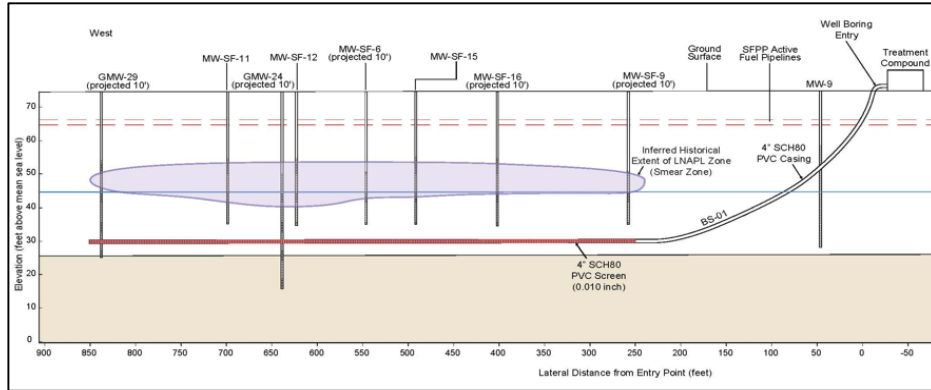
South-central Horizontal Biosparge Well

- Installed horizontal well in Q4 2015
- 850 feet long with 600 feet of screen
- Screen is located within the approximate extent of the dissolved phase in the south-central area and below the LNAPL smear zone (approximately 45-foot bgs)
- Operated from Q1 2016 to Q4 2019
- Highly successful; reached technical endpoint in 2+ years (significantly reduced LNAPL extent and mobility)
- Water Board endorsed plan for temporary shut-down in September 2019

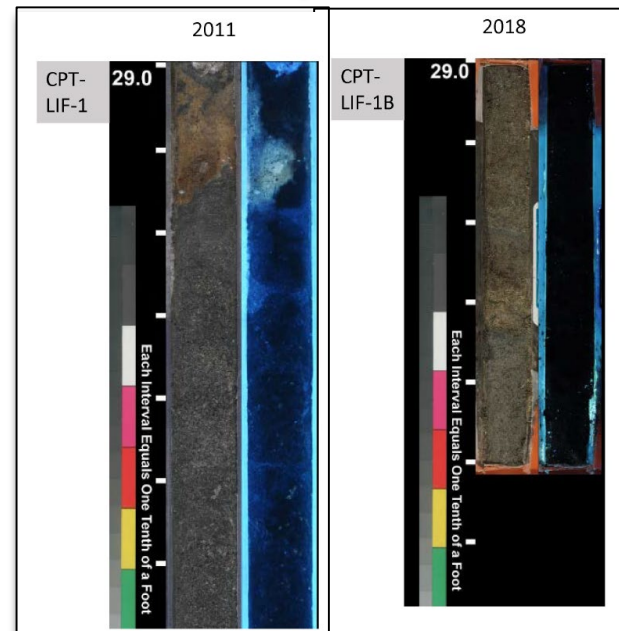
Soil Core Photograph Replicates

No visual fluorescence post biosparging

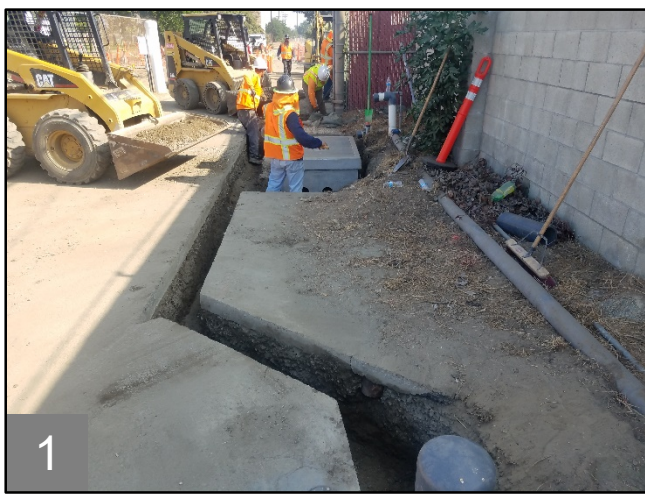
Photo 1 – Trenching
SVE lines (looking east
along ROW)

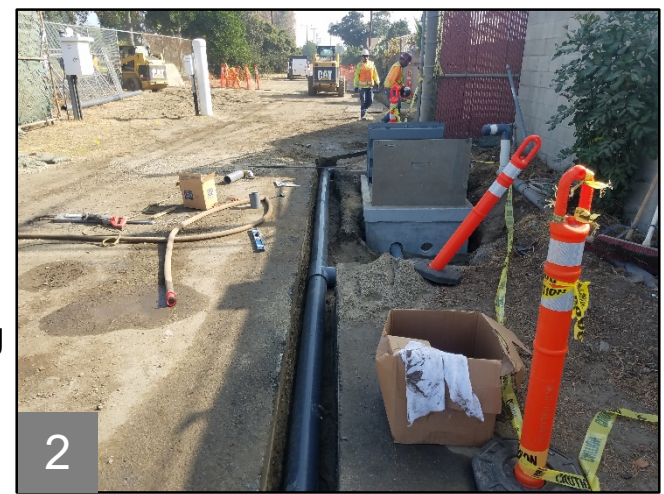
Photo 2 – Installing
SVE pipe (looking
east along ROW)

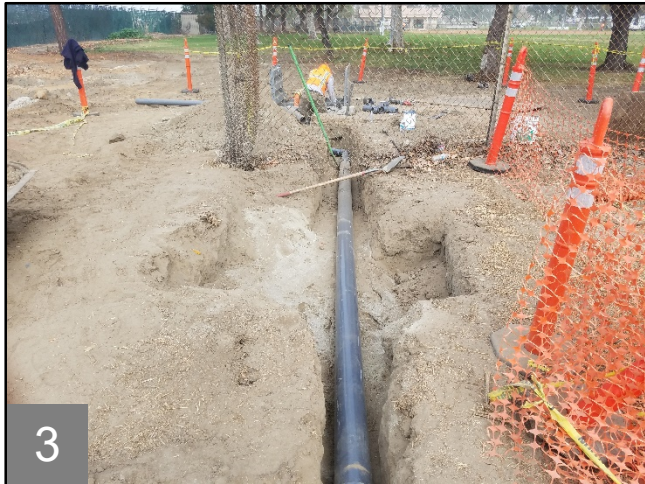
Photo 3 – Installing SVE
pipe (looking north
towards Holifield Park)

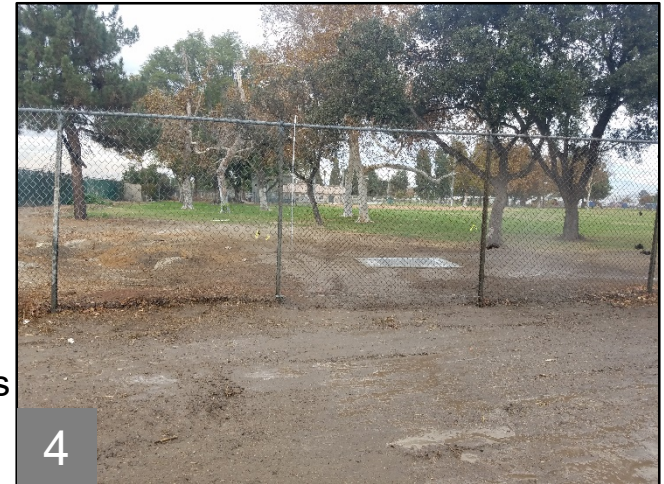
Photo 4 – After
installing SVE pipe
(looking north towards
Holifield Park)

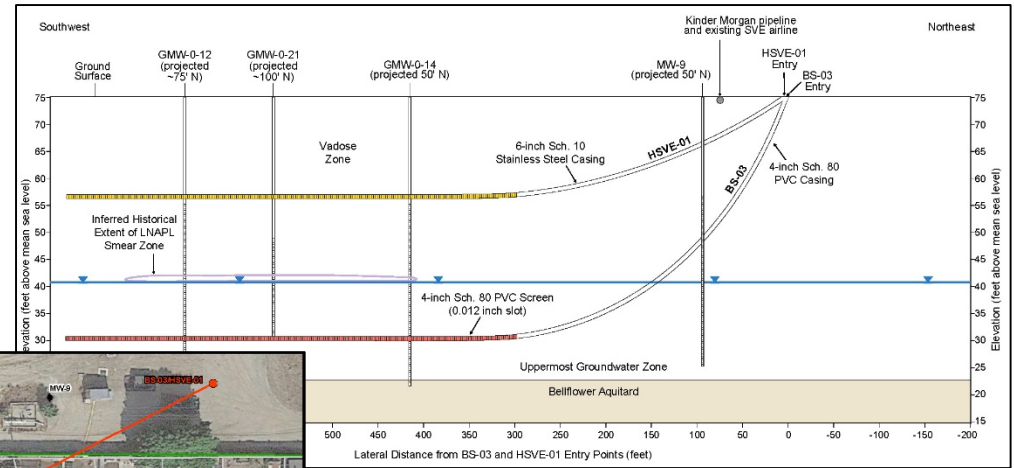
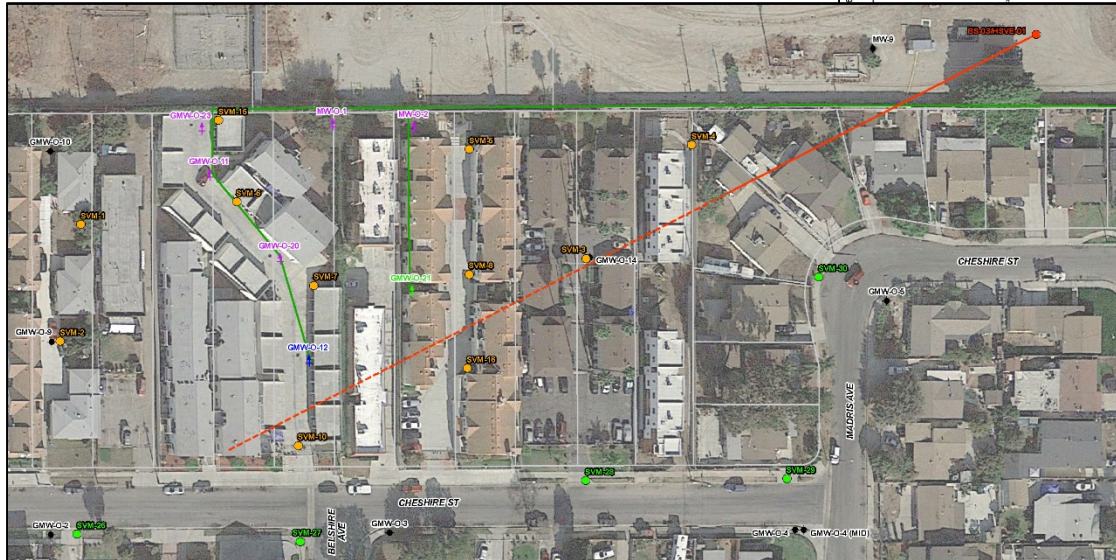
South-central/Offsite Horizontal Treatment Wells

- Installed vertically “stacked” biosparge and SVE wells in Q4 2019
- Biosparge well is 770 feet long, 500 ft screen, set at 45 feet bgs
- SVE well 742 feet long, 500 ft screen set at 21 feet bgs

- Screens are located within the approximate extent of the dissolved phase plume in the SC/offsite area
- SVE well primarily to manage vapors from biosparging
- Wells will be connected to treatment system in Q2 2020.
- Startup likely in second half of 2020

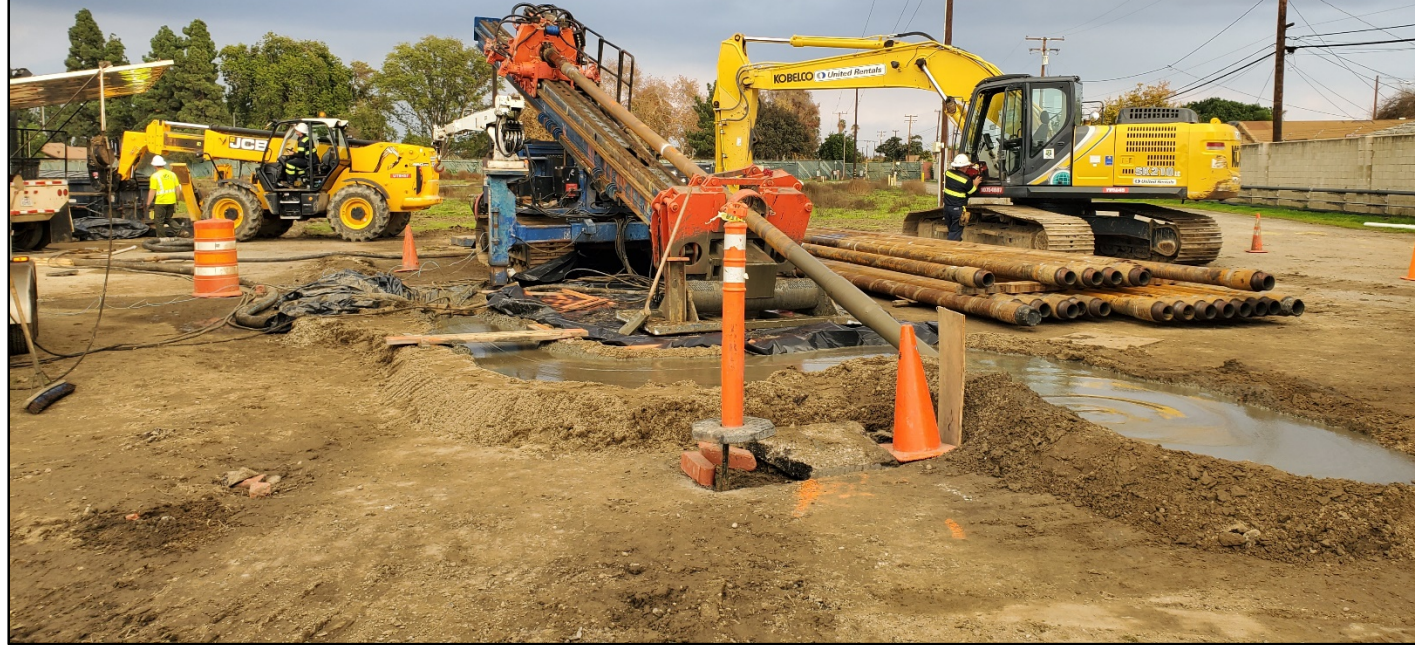
Photo 1 – Drilling the Horizontal SVE Well

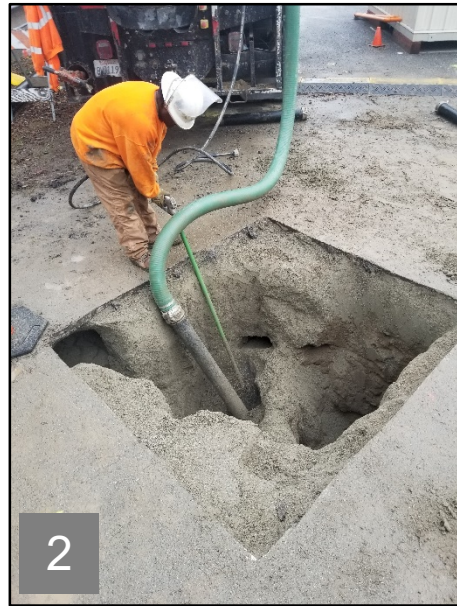
Photo 2 – Using Hydrovac to Expose Fuel Pipelines

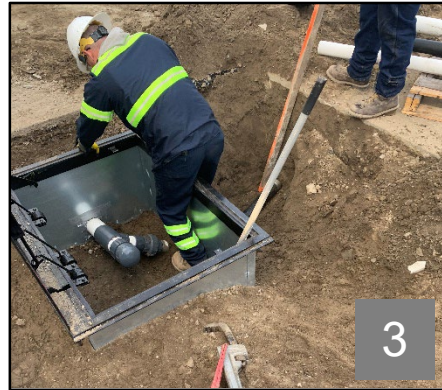
Photo 3 – Installing the Horizontal Biosparge Well Vault
