## DFSP Norwalk RESTORATION ADVISORY BOARD

August 22, 2019

# Status of Remediation System

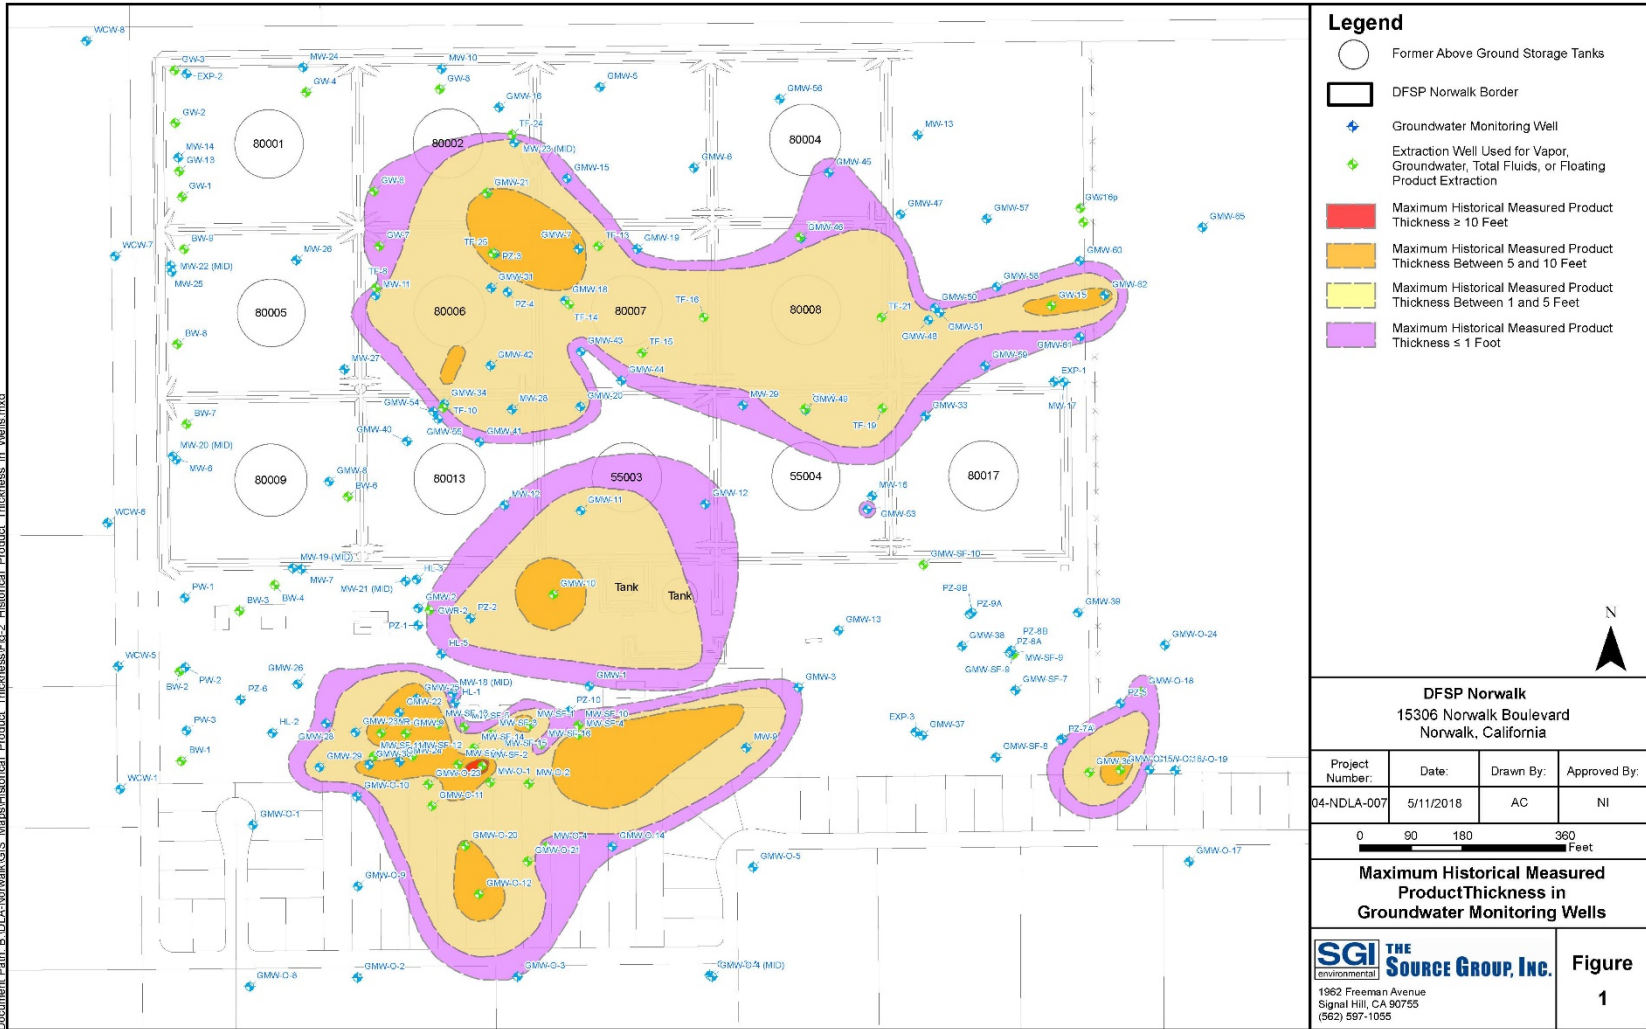
# LNAPL - Maximum

Document Path: B:\DLA-Norwalk\GIS\_Maps\Historical\_Product\_Thickness\Fig.2\_Historical\_Product\_Thickness\_in\_Wells.mxd

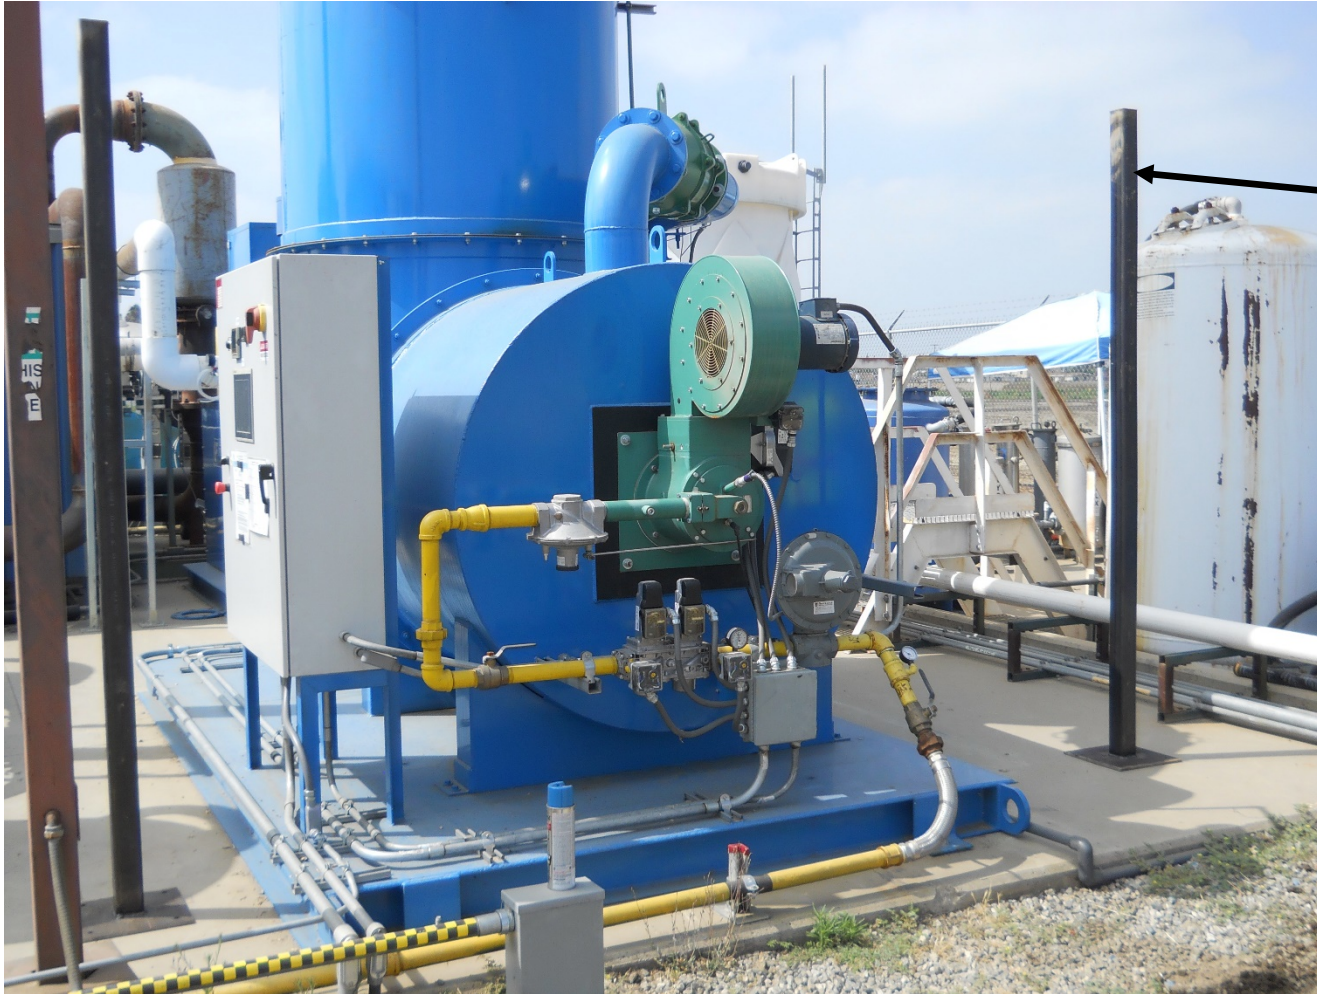
# ThermOx: Posts for Sound Blankets

**POST FOR  
SOUND  
BLANKETS**

- **New 3,000-scfm Natural Gas-fired Thermal Oxidizer has been tested, operated during the day; working on Sound Proofing**
- **Noise Study was Completed (findings on next Slide)**
  - **Recommended Sound Shields on Each Piece of Equipment**
  - **Sound Blankets will Add to Sound Deadening**
- **After Sound Proofing, Long-term, Full-time Operational Status of new Thermal Oxidizer will be Maintained.**
- **Noise Monitoring will be Completed in early stages at Property Boundary (Excelsior Blvd)**
- **Additional Vapor Extraction Capacity is provided by 500-scfm System Using Activated Carbon Treatment**
